Clarkson Township, Monroe
County, New York

Historic Site Survey

Prepared for the
Monroe County Community
Development Administration

July, 1987

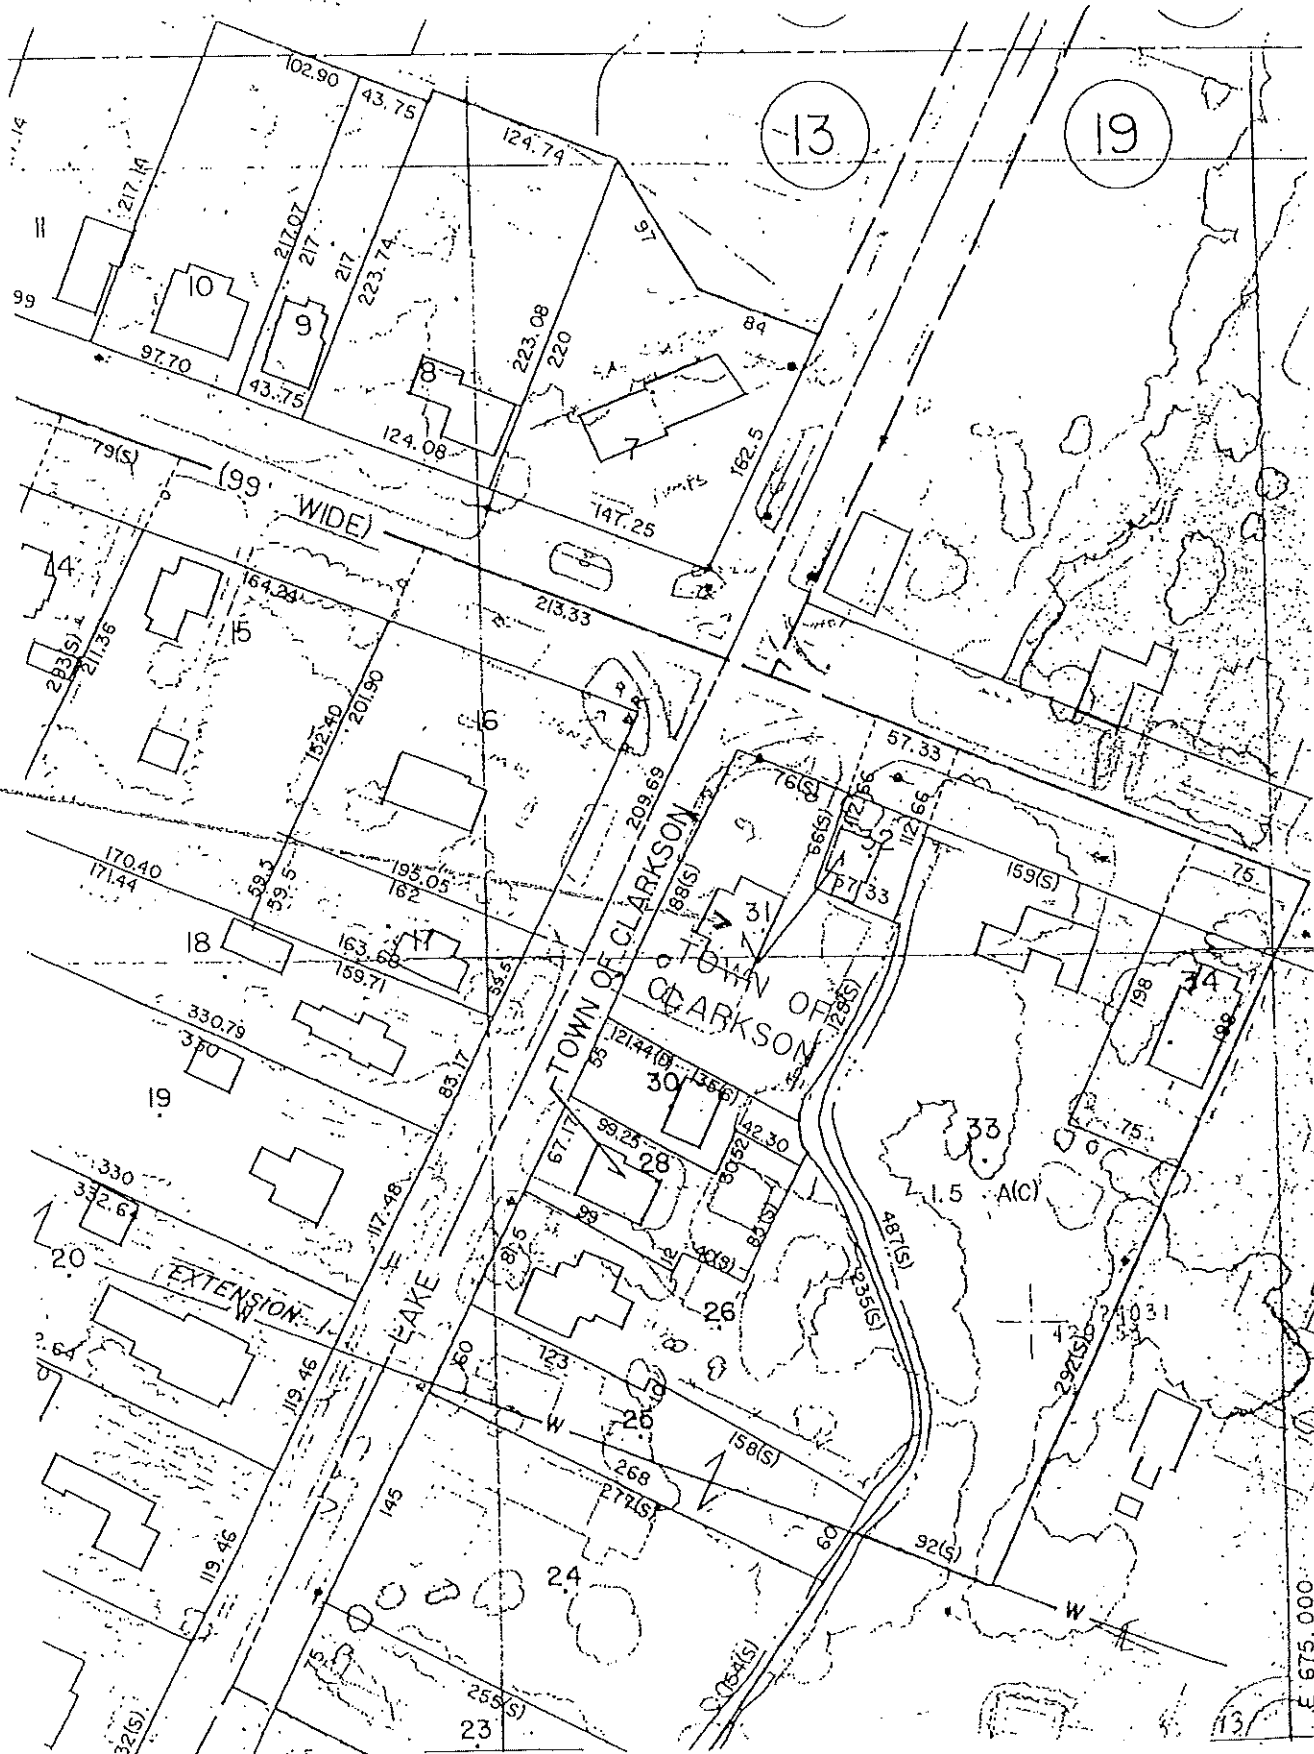
The Clarkson Town Hall
Clarkson, Monroe County
ATTACHMENT (1)

18. The Clarkson Town Hall reflects a neoclassical influence and features a full-height portico with bracketed pediment supported by Ionic columns. The gable roof is pierced by small peaked dormers reminiscent of Richardsonian "eyebrow" dormers. The entrance exhibits Adamesque influence with paired doors capped by a fanlight transom. Pilasters accent the facade to either side of the massive portico and windows are crowned with simple horizontal molding.

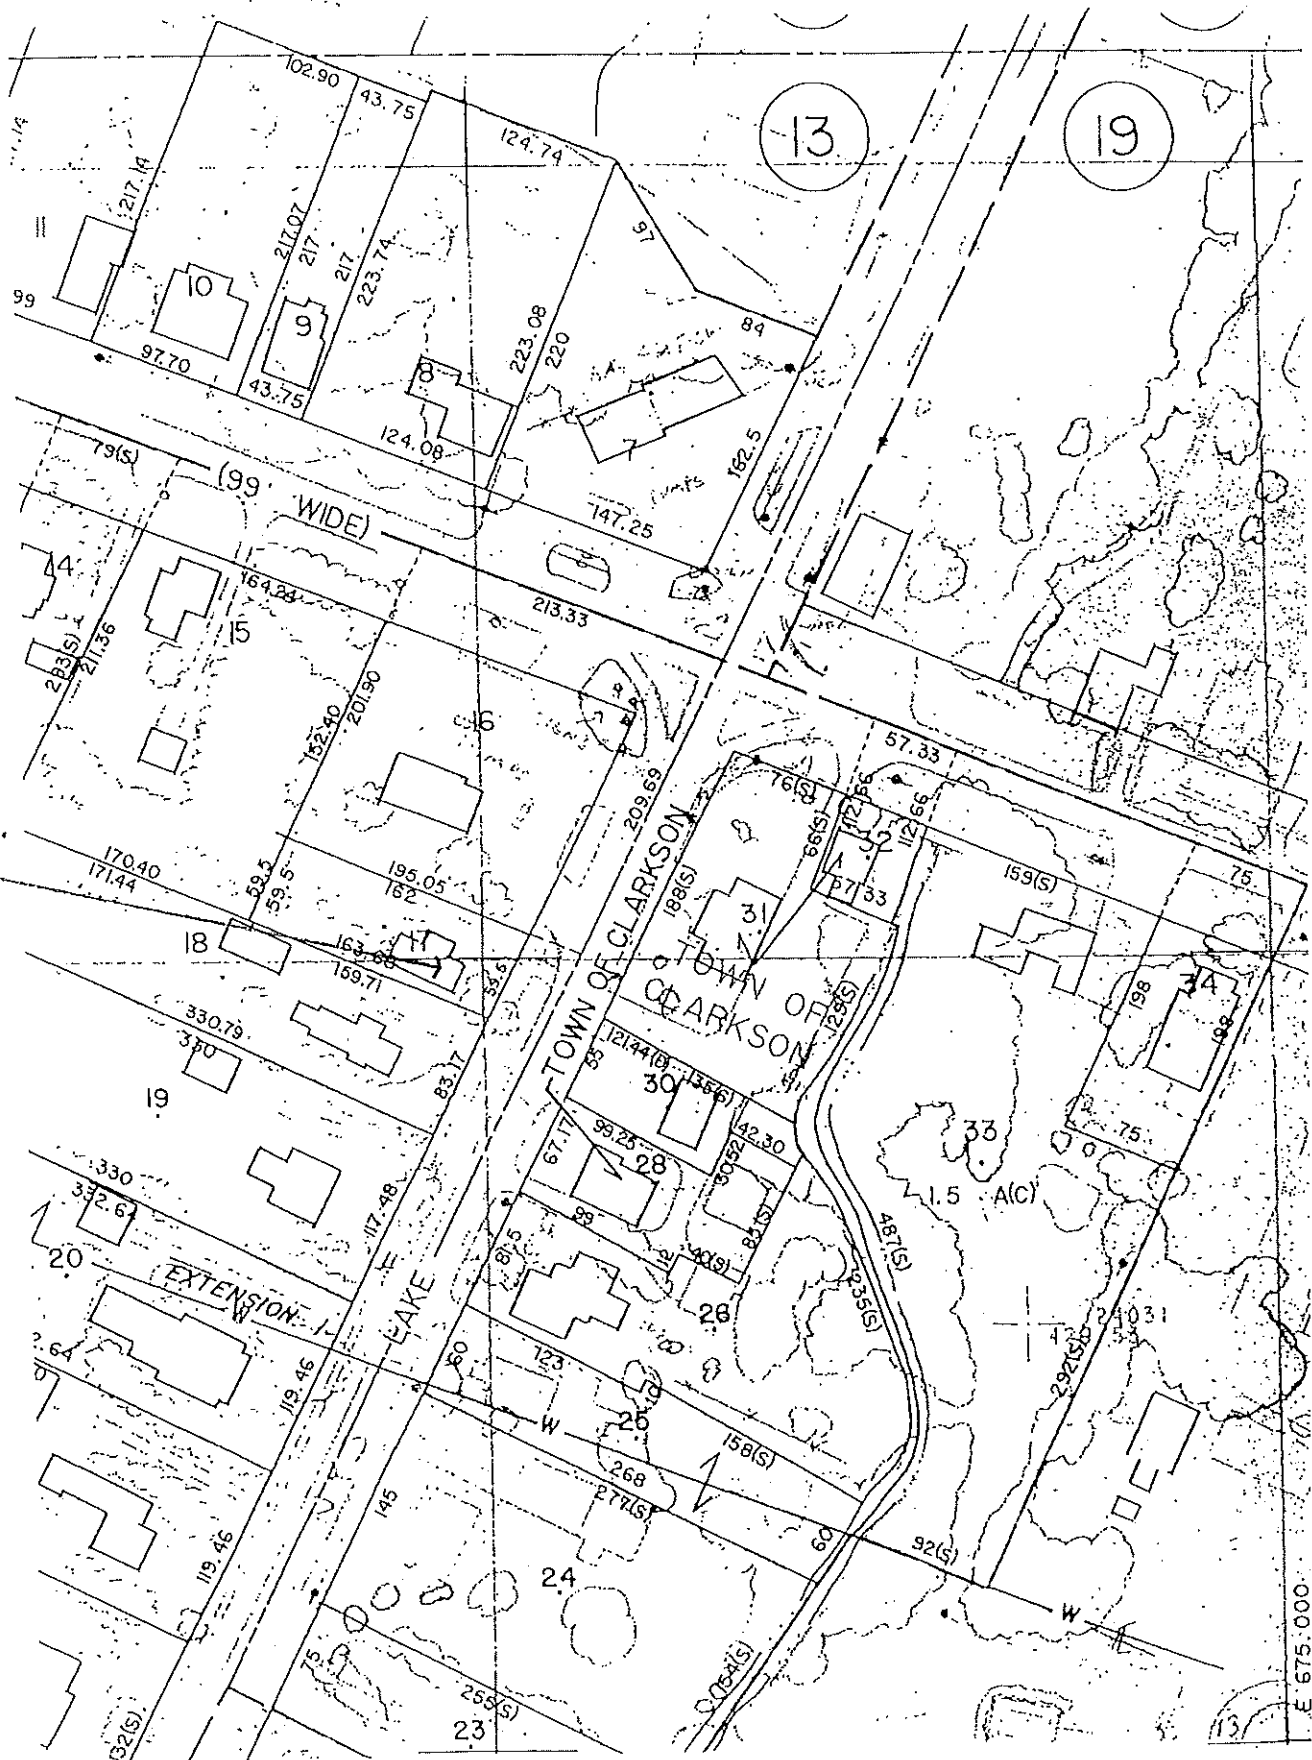
Winey House
15 Lake Rd.

#20. The Downey House is an important visual element in the continuity of Clarkson's most significant Federal and Greek Revival residential row and represents a break with traditional architectural styles of the past within the community. Folk Victorian forms were almost as prevalent in their day as were the earlier popular classical forms.

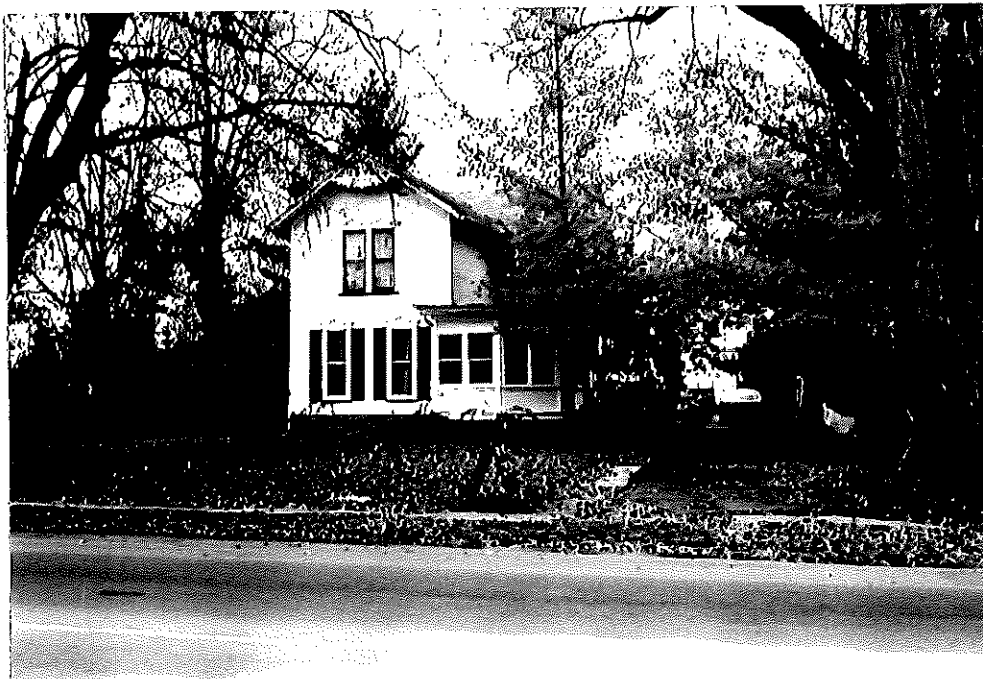
8. BUILDING MATERIAL: a. clapboard ☒ b. stone ☐ c. brick ☐ d. board and batten ☐
e. cobblestone ☐ f. shingles ☐ g. stucco ☐ other: _____
9. STRUCTURAL SYSTEM: a. wood frame with interlocking joints ☐
(if known) b. wood frame with light members ☒
c. masonry load bearing walls ☐
d. metal (explain) _____
e. other _____
10. CONDITION: a. excellent ☐ b. good ☒ c. fair ☐ d. deteriorated ☐
11. INTEGRITY: a. original site ☒ b. moved ☐ if so, when? _____
c. list major alterations and dates (if known):
enclosed front porch (date Unknown)

The Hixson-Clark House is Folk Victorian in form with a gable front and wing design. The front gable vergeboard is elaborately detailed and peaked lintels are found over the windows. An enclosed porch has been added at the intersection of the wings which, although functional in design, detracts from the Folk Victorian flavor of the house.

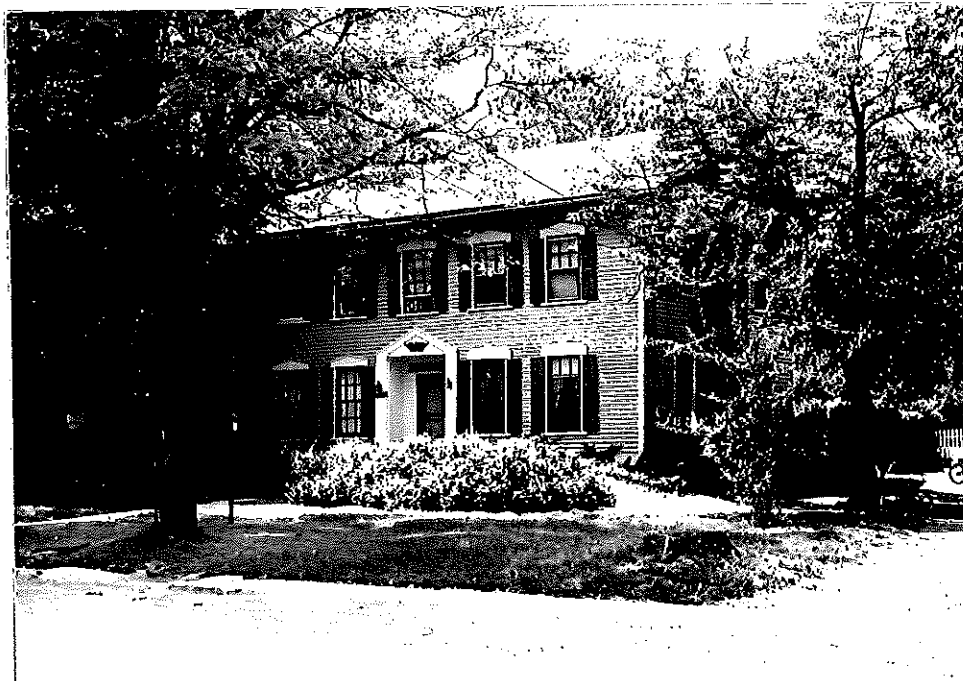
12. PHOTO:

8. BUILDING MATERIAL: a. clapboard ☒ b. stone ☐ c. brick ☐ d. board and batten ☐
e. cobblestone ☐ f. shingles ☐ g. stucco ☐ other: _____
9. STRUCTURAL SYSTEM: a. wood frame with interlocking joints ☐
b. wood frame with light members ☒
c. masonry load bearing walls ☐
d. metal (explain) _____
e. other _____
10. CONDITION: a. excellent ☒ b. good ☐ c. fair ☐ d. deteriorated ☐
11. INTEGRITY: a. original site ☐ b. moved ☒ if so, when? c. 1820
c. list major alterations and dates (if known):
rear addition (c. 1820)
north parlor enlarged (date unknown)

18. The Abel Baldwin House is a two-story, five-bay house with a side-gable roof. The house is similar in form to other Federal examples found primarily in New England. Framed with clapboards, the facade appears altered. The peaked window lintels and recessed front entrance are not common variations of the Adam style and were probably added at a later date. In mass and form, however, the house is distinctly Federal.

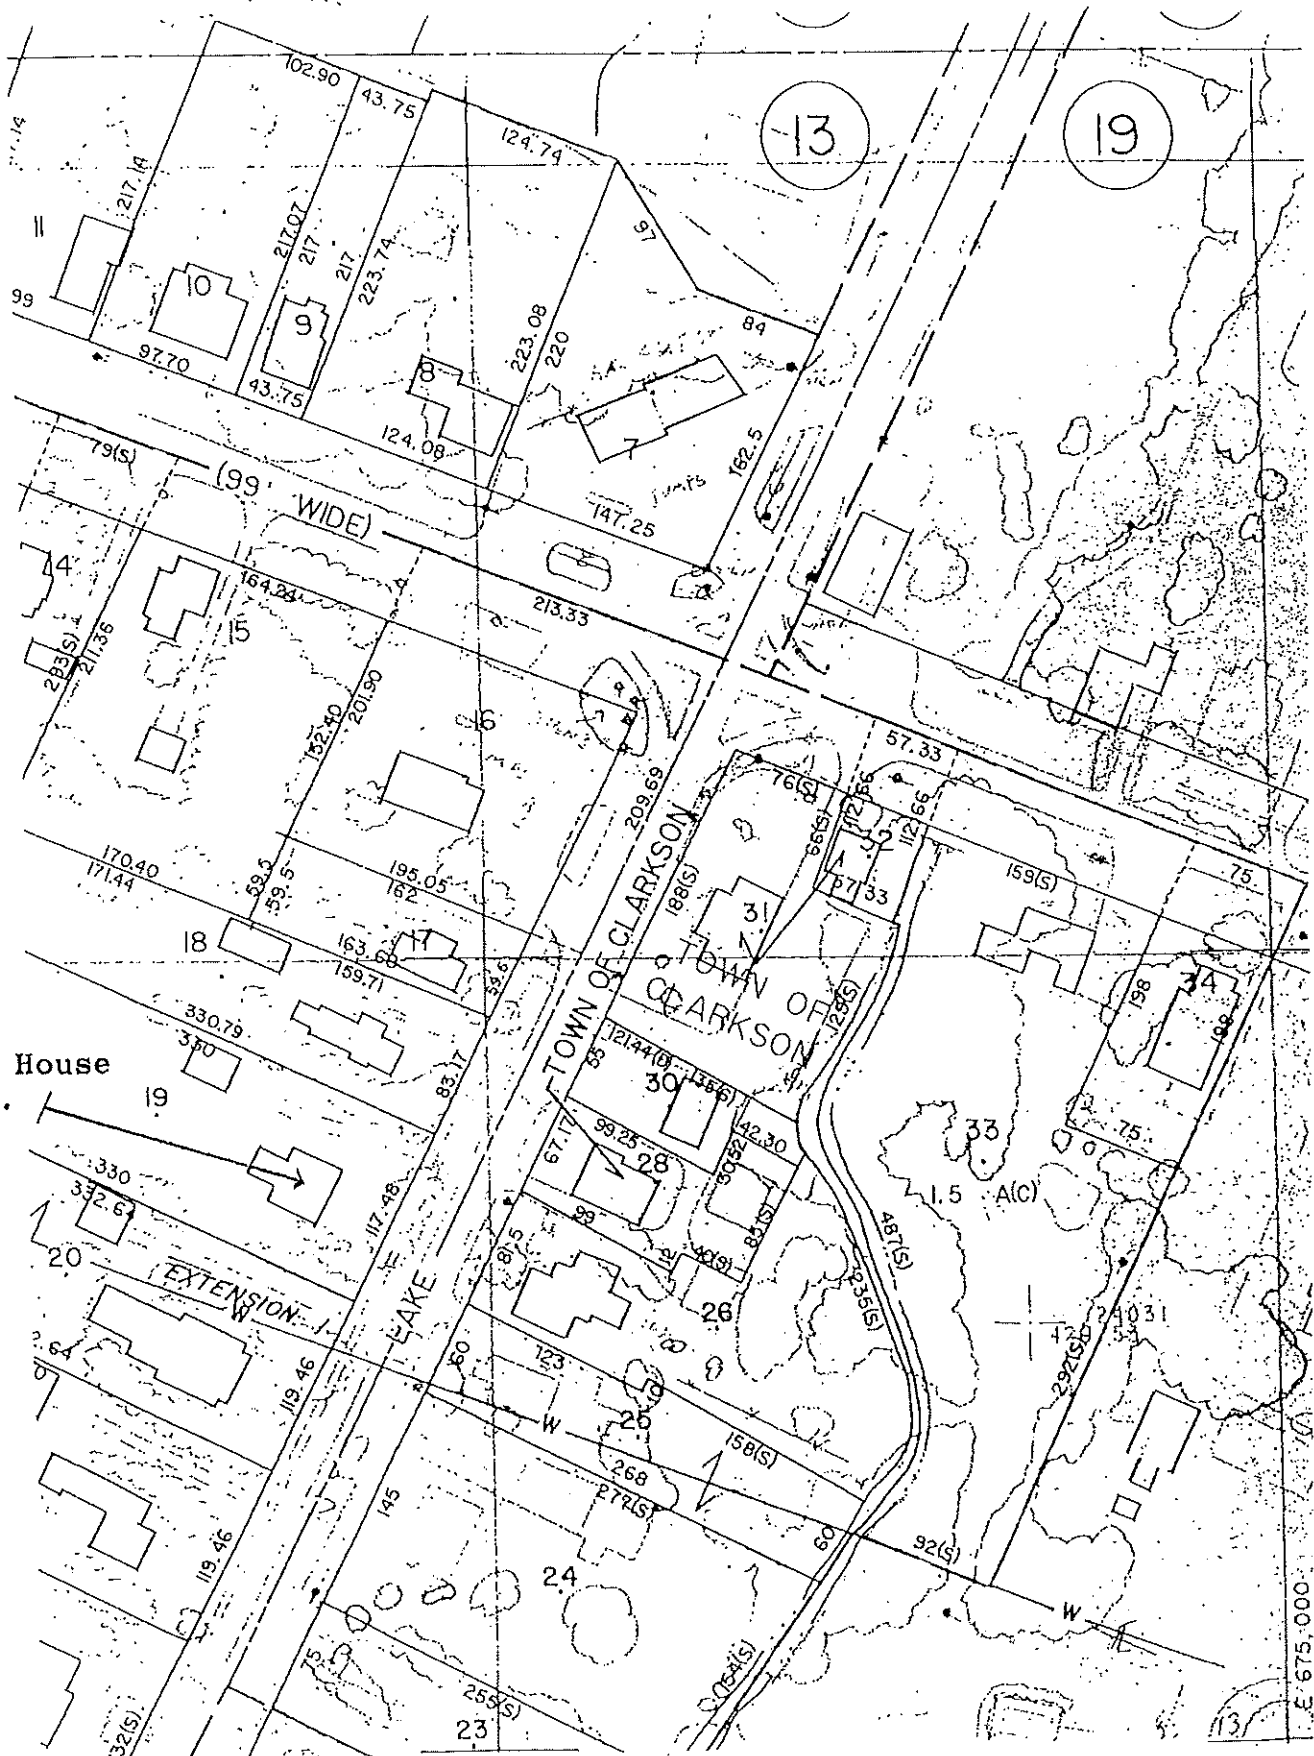
Abel Baldwin House
3731 Lake Rd.

20. Although the Abel Baldwin House was moved in 1820 from a prior location at the Clarkson four corners (current Lake Rd.-Ridge Rd. intersection), the house retains much of its original simplicity of form and detail. When originally constructed c. 1804, the house served as a tavern and also home for the Abel Baldwin family. The facade is a familiar Federal form reflecting the taste of settlers who migrated to the Genesee region of western New York from New England. Although the window surrounds and front entrance appear altered, the house in mass and form still reflects the early Federal influence from New England and remains an important example of this style in Clarkson and Monroe County.

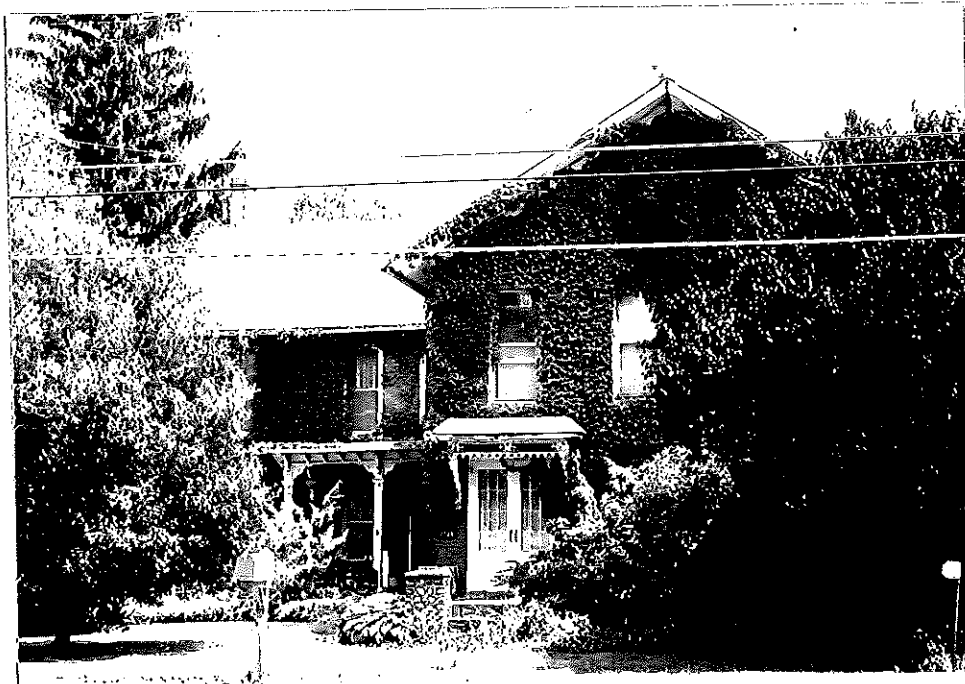
8. BUILDING MATERIAL: a. clapboard ☐ b. stone ☐ c. brick ☒ d. board and batten ☐
e. cobblestone ☐ f. shingles ☐ g. stucco ☐ other: _____
9. STRUCTURAL SYSTEM: a. wood frame with interlocking joints ☐
(if known) b. wood frame with light members ☐
c. masonry load bearing walls ☒
d. metal (explain) _____
e. other _____
10. CONDITION: a. excellent ☐ b. good ☒ c. fair ☐ d. deteriorated ☐
11. INTEGRITY: a. original site ☒ b. moved ☐ if so, when? _____
c. list major alterations and dates (if known):
cobblestone porch piers (date unknown)

18. OTHER NOTABLE FEATURES OF BUILDING AND SITE (including interior features if known):
 This house is a masonry asymmetrical Victorian design with Eastlake spindlework evident on the porch. The gable front and wing design is common. The front entrance features double glass pane doors and an unusual oculus is centered within the broken pediment. Cobblestone porch walls are non-contributing.

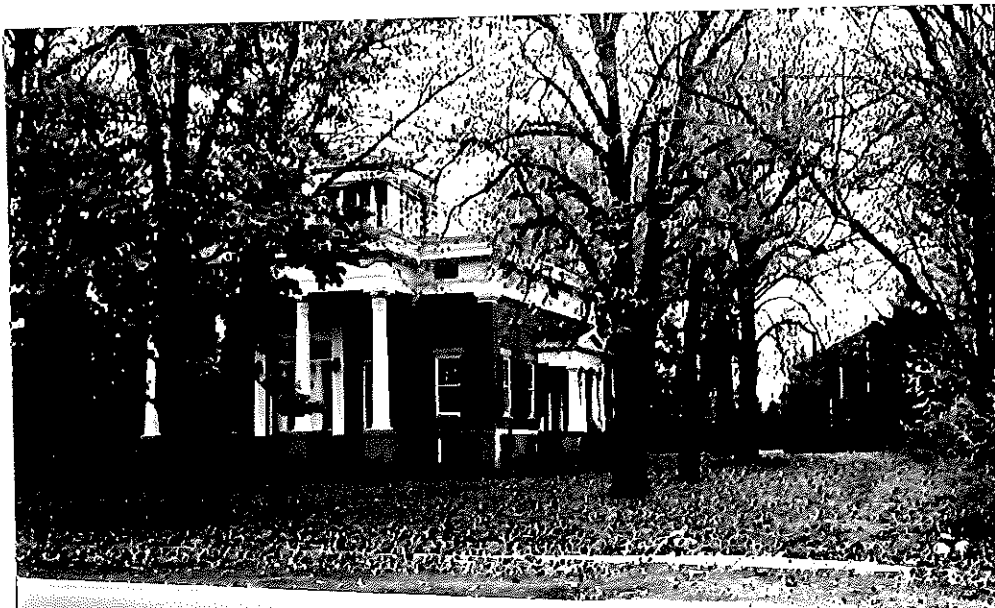
8. BUILDING MATERIAL: a. clapboard ☐ b. stone ☐ c. brick ☒ d. board and batten ☐
e. cobblestone ☐ f. shingles ☐ g. stucco ☐ other: _____
9. STRUCTURAL SYSTEM: a. wood frame with interlocking joints ☐
b. wood frame with light members ☐
c. masonry load bearing walls ☒
d. metal (explain) _____
e. other _____
10. CONDITION: a. excellent ☒ b. good ☐ c. fair ☐ d. deteriorated ☐
11. INTEGRITY: a. original site ☒ b. moved ☐ if so, when? _____
c. list major alterations and dates (if known):
two-car attached garage

18. The Bowman House was originally constructed in 1850 as a Greek Revival residence and is one of western New York's most outstanding examples of the classical style. The house is massive in scale with a square main block closely resembling three similar mansions found on East Ave. in Rochester, N.Y. However, the two-story pedimented portico is unique and adds magnitude in scale. The surmounting glazed cupola contributes central unity to the entire structure.

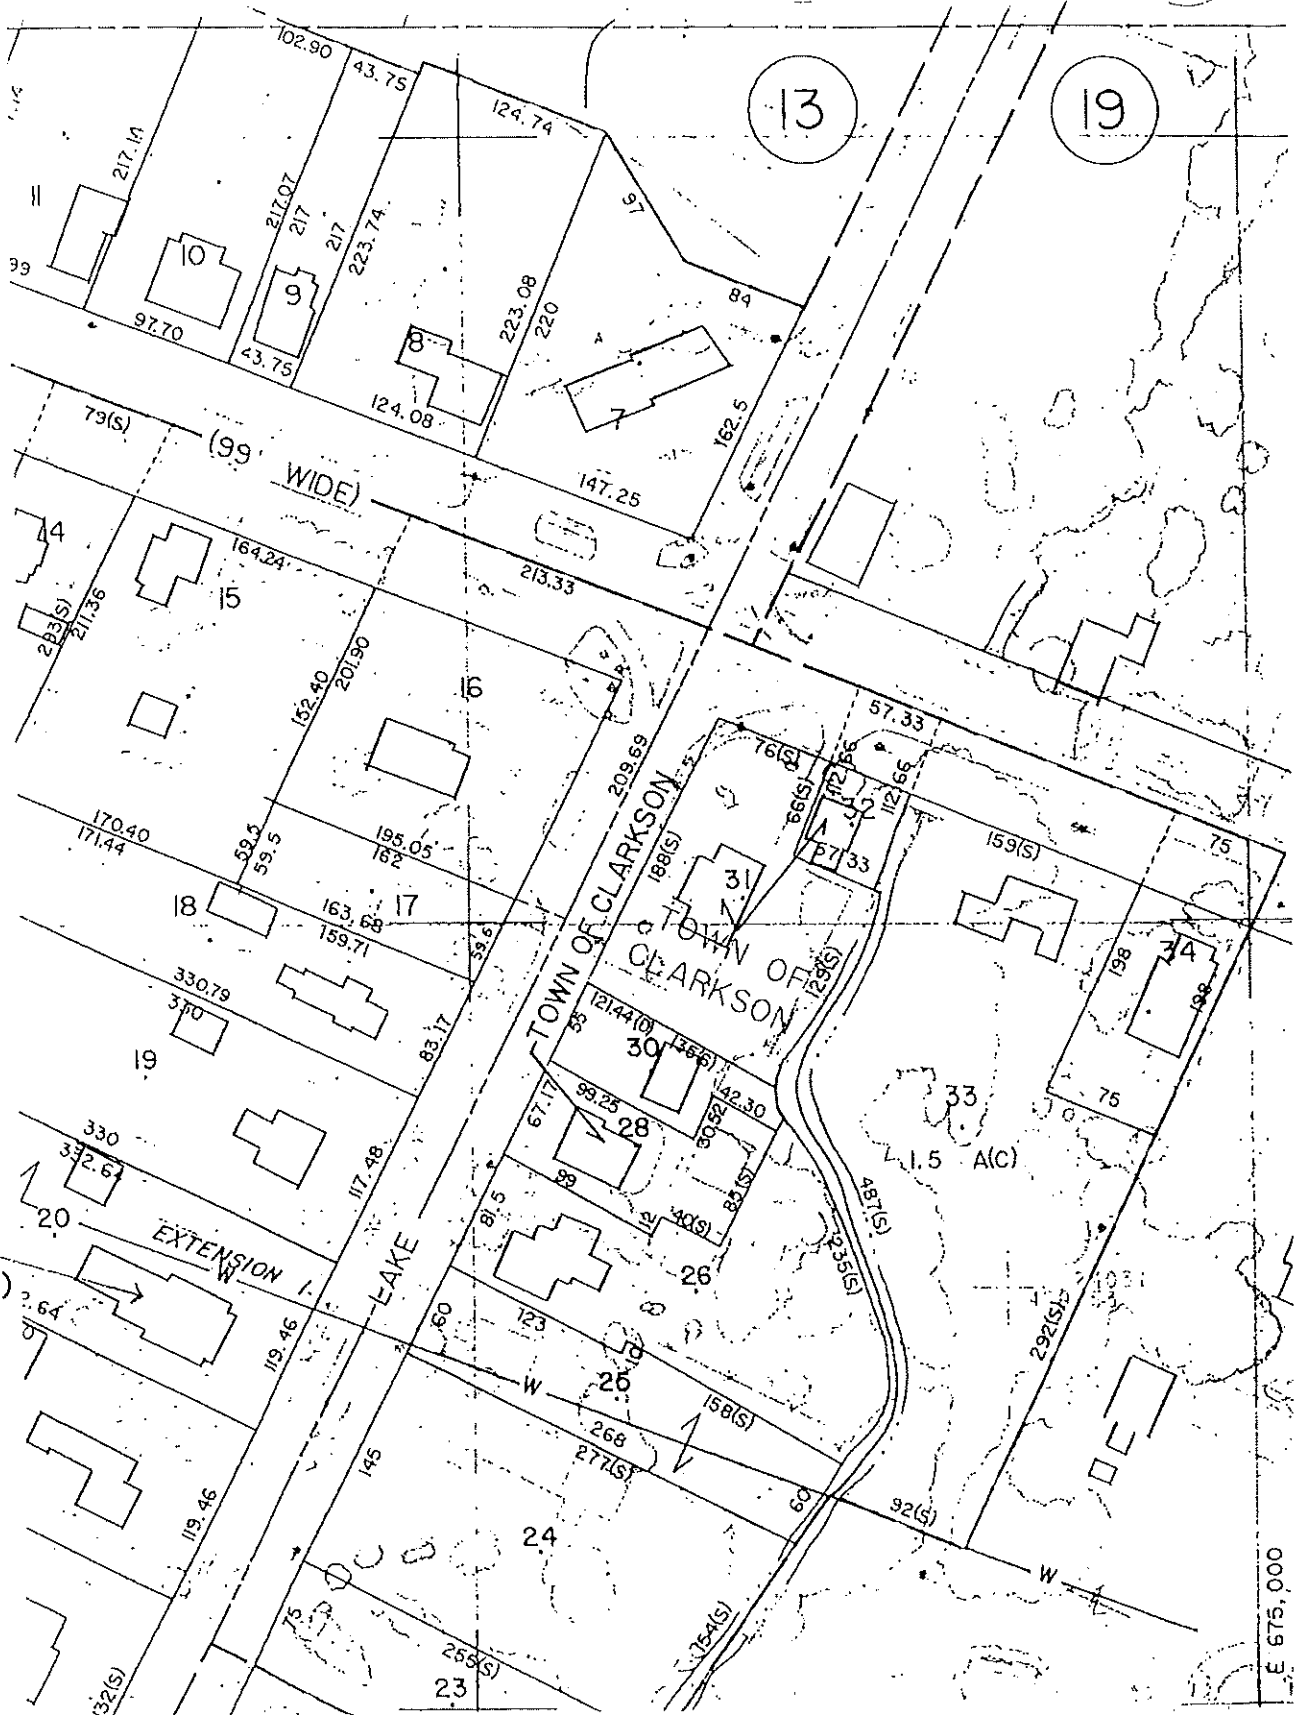
The
Bowman
House
(3741 Lake Rd.)

20. John Bowman was the son of Clarkson's first lawyer, Judge John Bowman. Local lore has it that after building the house for his fiancée, John Bowman disappeared to New York City never to return. In any event, the house has remained a comfortable residence since 1850 and, as a consequence, has been well-preserved with little desecration or alteration. The square compact massing combined with classical monumental detailing creates a very appealing proportional solidity not found elsewhere in the region. Although larger Greek Revival structures exist in Rochester and Monroe County, none achieve the solid proportional impact of the smaller Bowman House. The Bowman House accordingly ranks as an extremely significant example of late Greek Revival architecture within the Monroe County region and is the architectural crown jewel of the historic homes located within the local Clarkson historic overlay district.

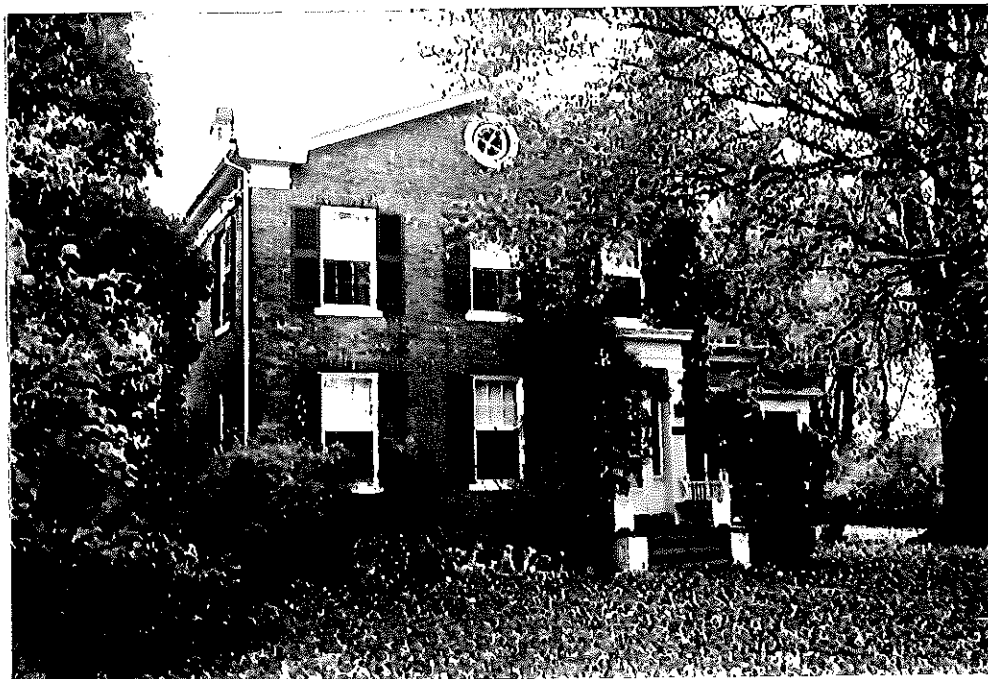
8. BUILDING MATERIAL: a. clapboard ☐ b. stone ☐ c. brick ☒ d. board and-batten ☐
e. cobblestone ☐ f. shingles ☐ g. stucco ☐ other: _____
9. STRUCTURAL SYSTEM: a. wood frame with interlocking joints ☐
(if known) b. wood frame with light members ☐
c. masonry load bearing walls ☒
d. metal (explain) _____
e. other _____
10. CONDITION: a. excellent ☒ b. good ☐ c. fair ☐ d. deteriorated ☐
11. INTEGRITY: a. original site ☒ b. moved ☐ if so, when? _____
c. list major alterations and dates (if known): _____

18. The Lee-Duryea House is a handsome and less elaborate Greek Revival example than its magnificent neighbor to the north, the Bowman House. The three-bay front gable facade features an off-set front entrance, broken pediment and an oculus centered below the gable end peak. The classical entablature of the eave and door surround is plain and unadorned with dentils or brackets. The door surround features rectangular sidelights and transom encased within a decorative enframement. The sidelights are flanked by square Doric columns. The smaller attached northern wing adds central unity to the off-set design. A front gabled carriage house with a matching oculus stands behind and north of the main house. This outbuilding is a rectangular two-story apartment building with cedar shake siding.

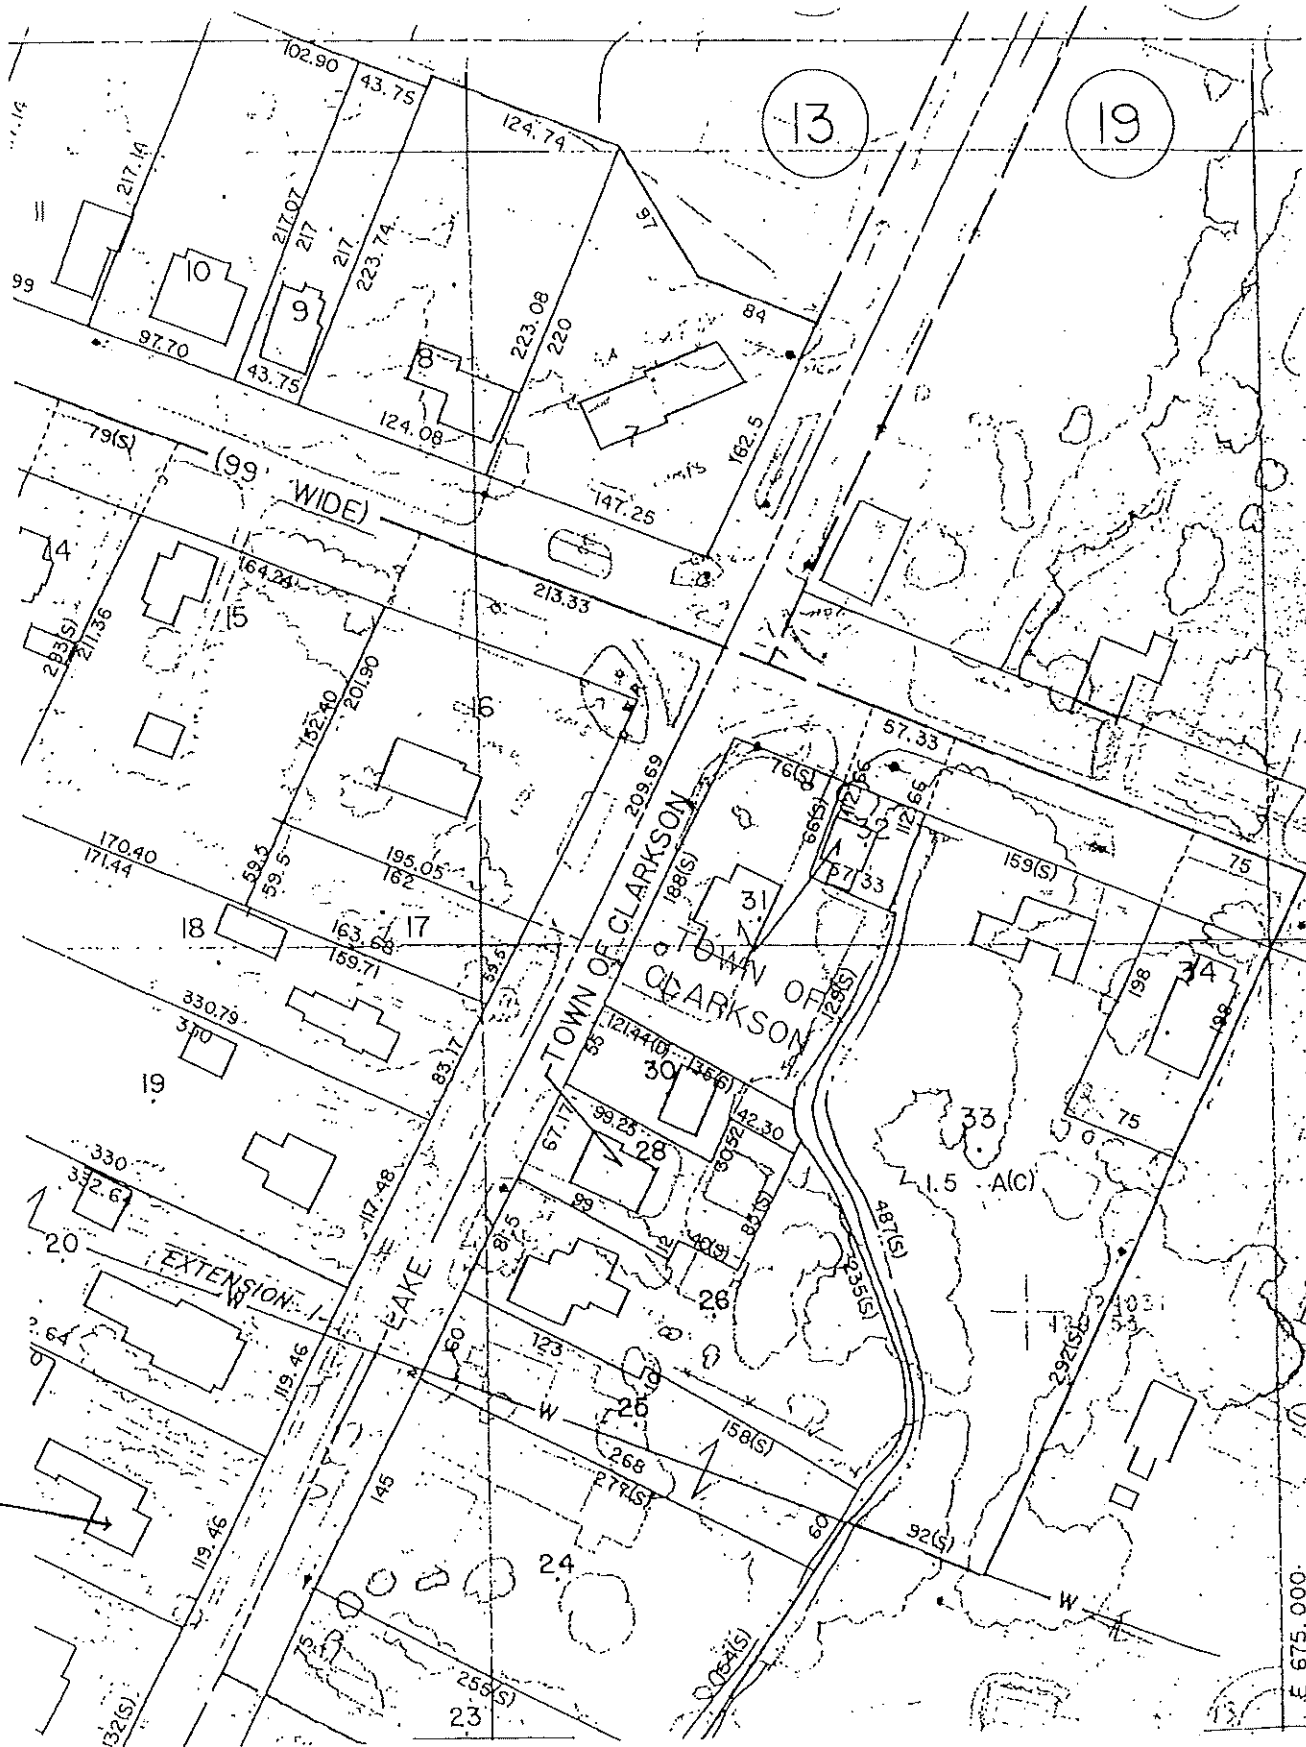
20. The Lee-Duryea House is yet another fine example of the architectural diversity found within the local Clarkson Historic Overlay District. The gable front and wing construction is a familiar Greek Revival variation yet the Lee-Duryea House exhibits its own unique compact massing and scale. Built in c. 1840 as a private residence, the house has experienced few period stylistic alterations evident on other Clarkson homes. Greek Revival detailing and characteristics have remained relatively intact. This house and the Bowman House are the two surviving extant examples of essentially unaltered Greek Revival architecture left in Clarkson. The Lee-Duryea House is significant as an intact surviving model of rural classical architecture and is an important component of Clarkson's most important historic residential row.

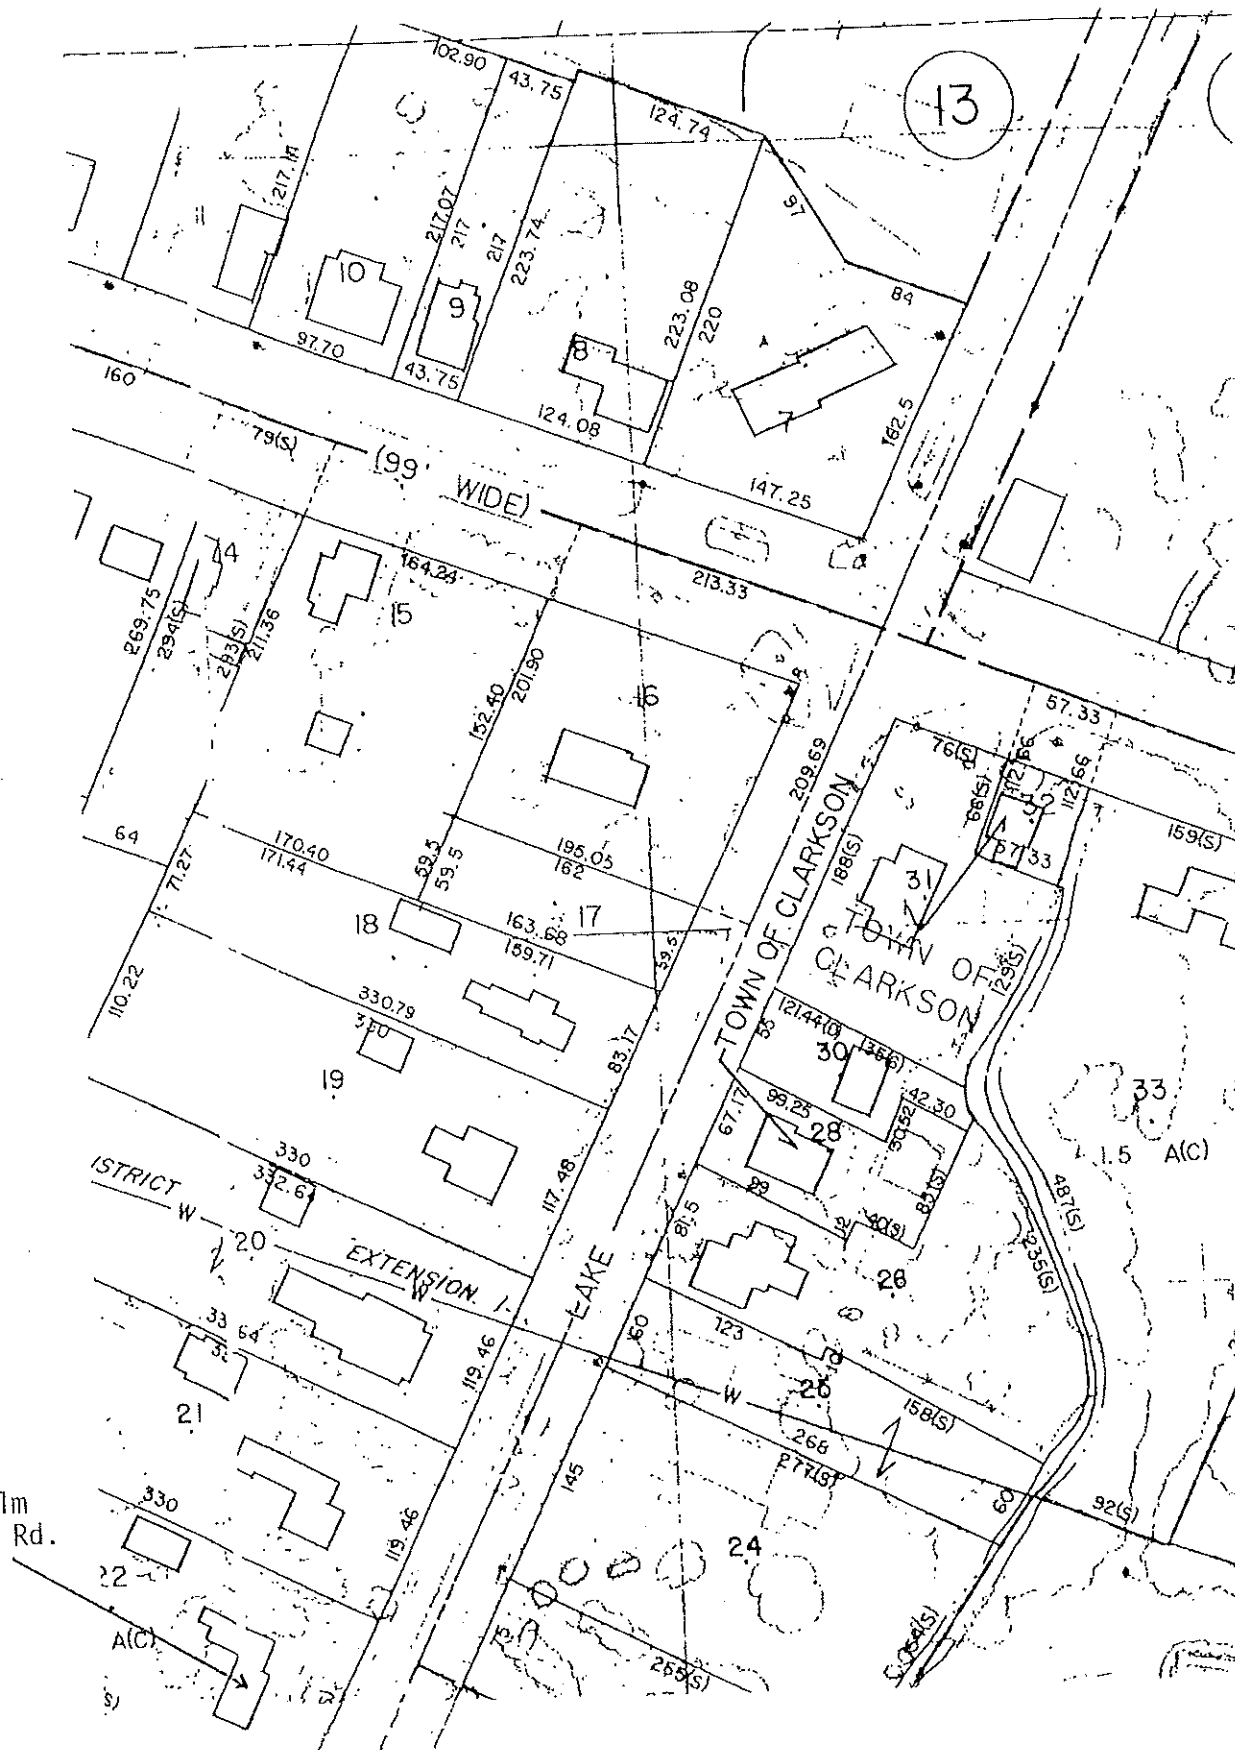
18. The Haskell-Anselm House is an excellent example of the Greek Revival style in Clarkson. The house features a typical five-bay center entrance facade with gable wing. Classical detailing is plain with no dentils or brackets. The doorway is plain with no elaborate decorative surround. The one-bay entrance porch features Doric columns which do not match in scale or entasis. The gable wing has several small frieze windows and an Italianate one-story porch. Each window is crowned with a flat brick arch and flanked by bevelled shutters.

20. The Haskell-Anselm House retains much of its original 1840's Greek Revival detailing which emphasized classical simplicity and symmetry of form. The main block with its Doric porch and wide entablature emphasizes this classical simplicity and offers a charming contrast to the offset facade of the Lee-Duryea House next door and the ornate Bowman House nearby. The bracketed Italianate porch does not detract from the Greek Revival character of the house and is a fine example of Romantic craftsmanship. The Haskell-Anselm House is an important link in Clarkson's most historic and architecturally significant residential row.

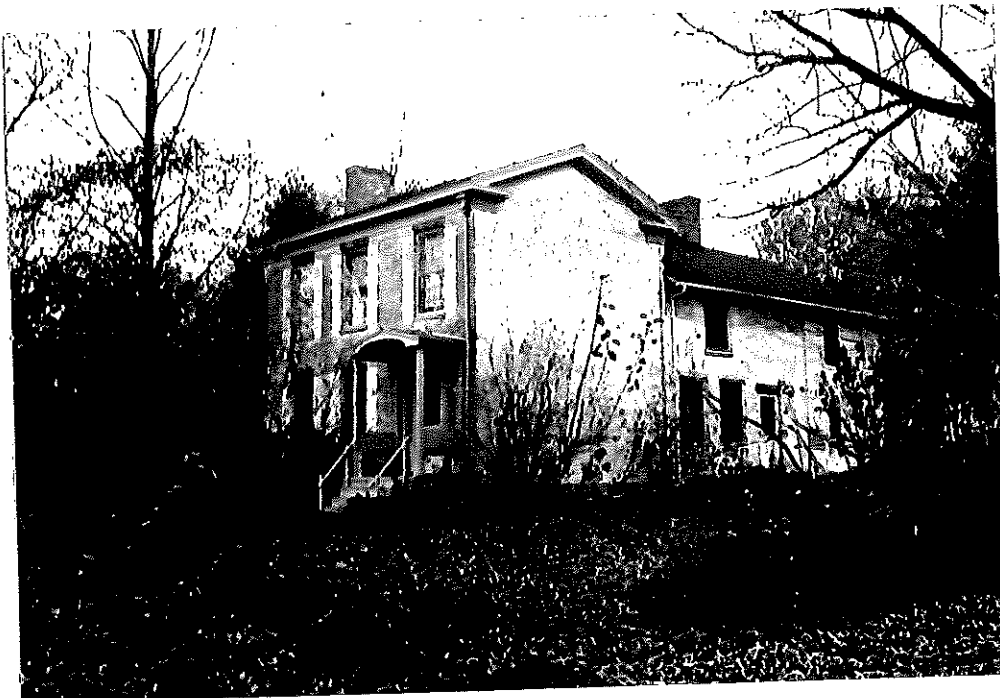
8. BUILDING MATERIAL: a. clapboard ☐ b. stone ☐ c. brick ☒ d. board and-batten ☐
e. cobblestone ☐ f. shingles ☐ g. stucco ☐ other: _____
9. STRUCTURAL SYSTEM: a. wood frame with interlocking joints ☐
b. wood frame with light members ☐
c. masonry load bearing walls ☒
d. metal (explain) _____
e. other rear addition: wood frame
10. CONDITION: a. excellent ☒ b. good ☐ c. fair ☐ d. deteriorated ☐
11. INTEGRITY: a. original site ☒ b. moved ☐ if so, when? _____
c. list major alterations and dates (if known):
rear frame addition (date unknown)
front porch (1985)

18. The Simeon Jewett House features a three-bay facade with offset front entrance enhanced by another of the exquisite Federal door surrounds found in Clarkson. The entrance is flanked by sidelights framed between paired Ionic colonnettes and a fanlight transom crowns the door. Geometric tracery patterns grace both the sidelight and transom. The Jewett House is similar in form to its neighbor, the Fowler House. The wooden fence which delineates the front edge of the property is uniquely designed and adds a substantial historic ambiance to the site.

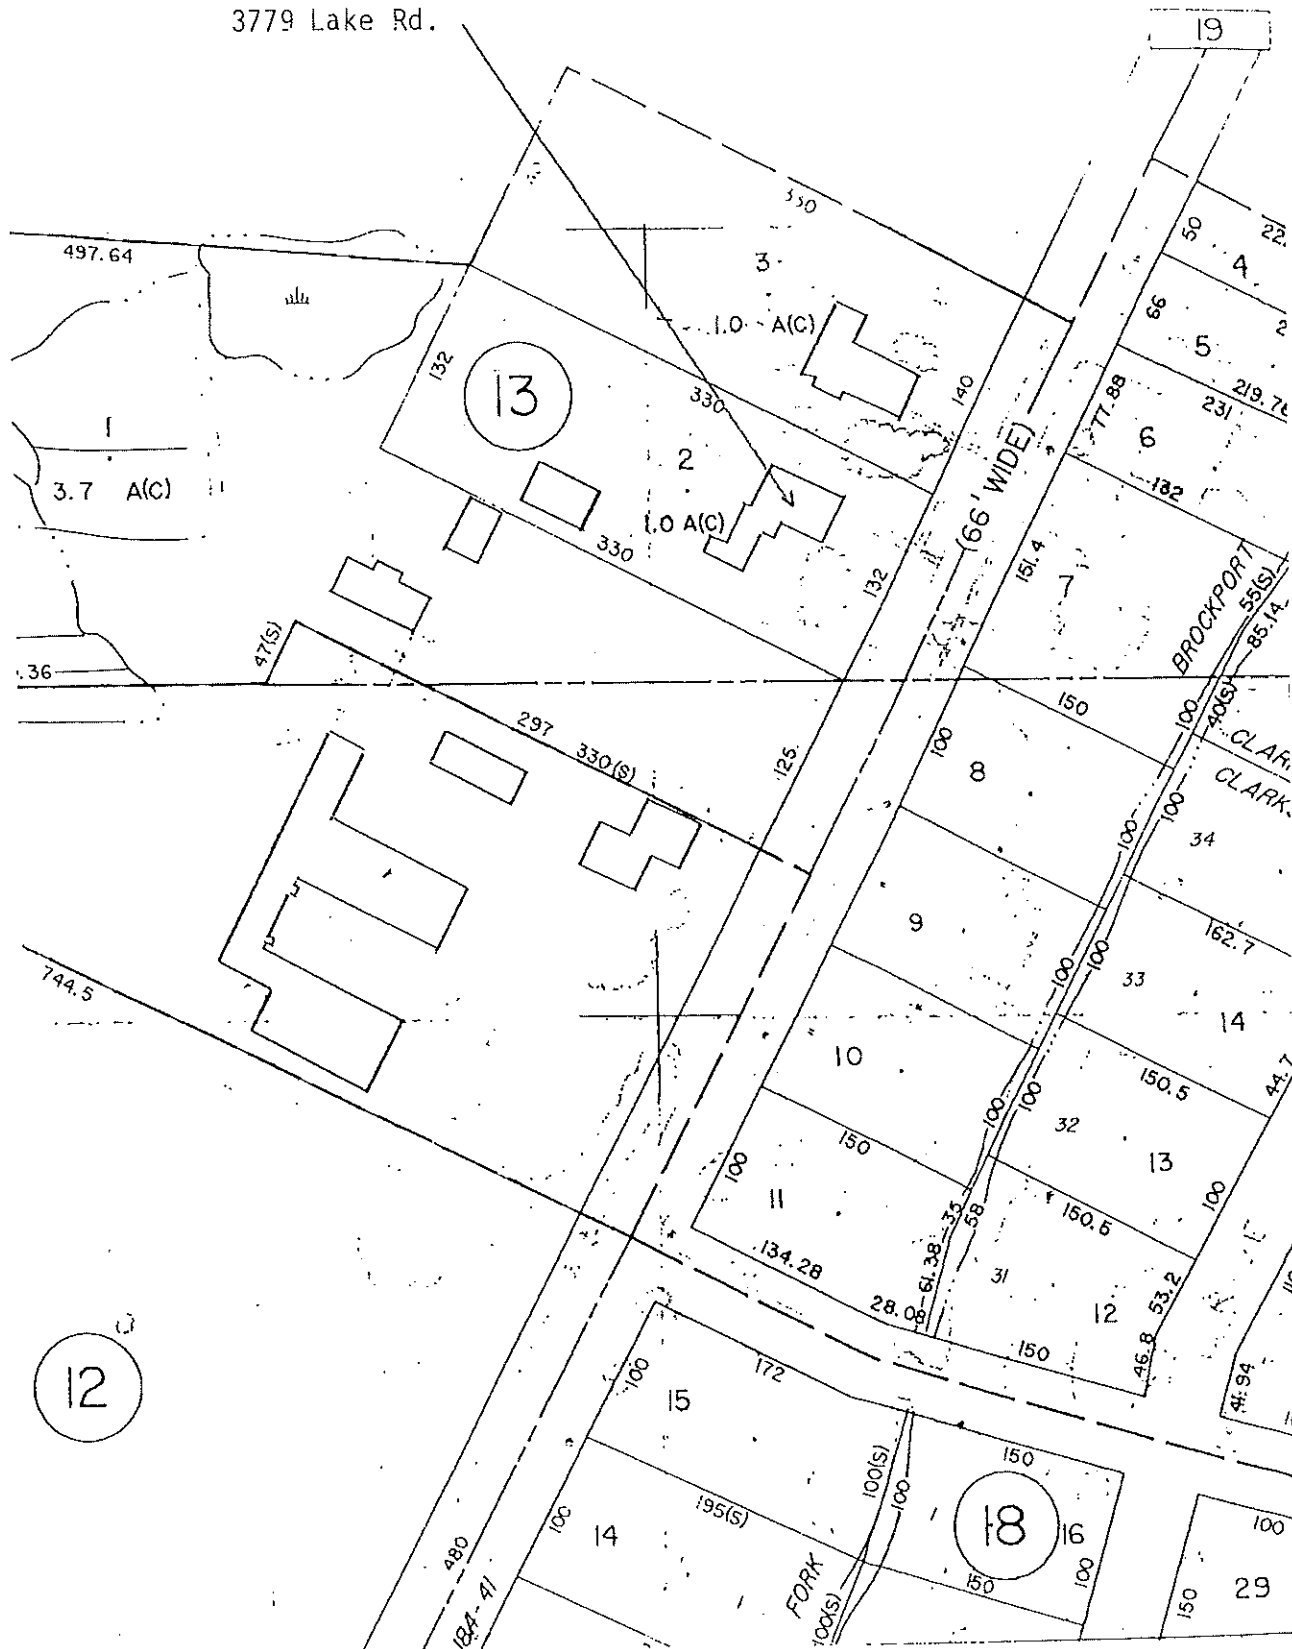
The Simeon Jewett House
3779 Lake Rd. \

Architecturally, the Jewett House retains much of the simple elegance and charm of its early Federal influence. A unique characteristic of the house is its relatively unaltered state. The present owners have removed the front shutters and added a non-contributing front porch incompatible with the original design. A contributing heavy timber frame wing extending south from the house may also be altered or removed. Even so, the Simeon Jewett House remains one of the most important examples of Federal architecture in Monroe County with high architectural and historic merit.
