Clarkson Township, Monroe
County, New York

Historic Site Survey

Prepared for the
Monroe County Community
Development Administration

July, 1987

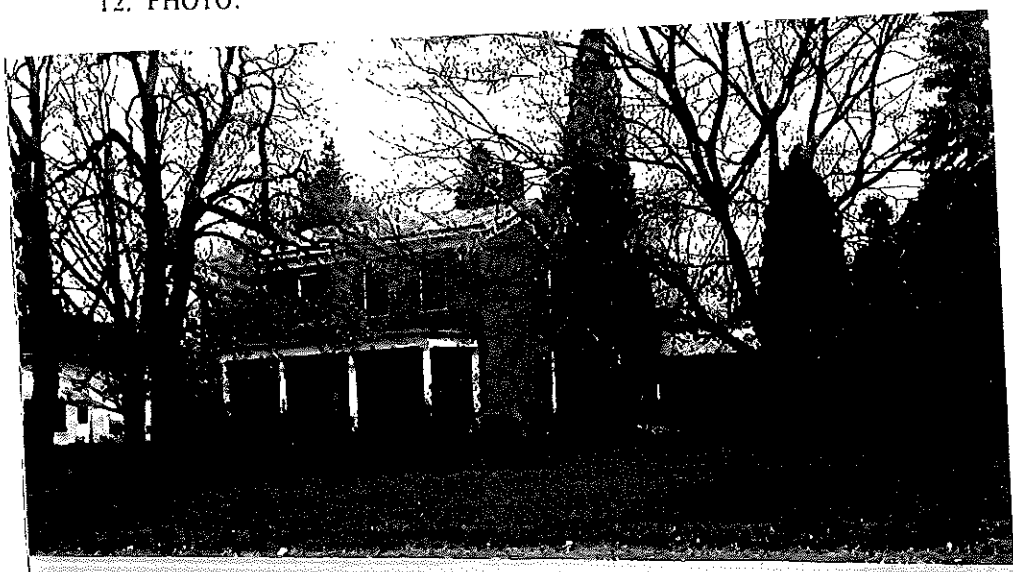
8. BUILDING MATERIAL: a. clapboard ☐ b. stone ☐ c. brick ☒ d. board and-batten ☐
e. cobblestone ☐ f. shingles ☐ g. stucco ☐ other: _____
9. STRUCTURAL SYSTEM: a. wood frame with interlocking joints ☐
b. wood frame with light members ☐
c. masonry load bearing walls ☒
d. metal (explain) _____
e. other _____
10. CONDITION: a. excellent ☐ b. good ☒ c. fair ☐ d. deteriorated ☐
11. INTEGRITY: a. original site ☒ b. moved ☐ if so, when? _____
c. list major alterations and dates (if known):
kitchen wing added (c. 1835)
porch added (c. 1840)
eaves altered (c. 1893)

18. The front (east) facade of the Fowler House is a three-bay offset facade with a distinctive Federal doorway and full width Greek Revival porch which adds horizontal massing to this elevation. The entrance surround is of the type commonly found in Clarkson and features delicate lead tracery in the sidelights and fanlight. The sidelights rest between paired Ionic colonnettes not fluted but with a delicate entasis. The doorway is accented by wooden pilasters. Plain decorative Italianate eave brackets nicely complement the unadorned porch entablature and are an acceptable alternative to dentils or other moulding.

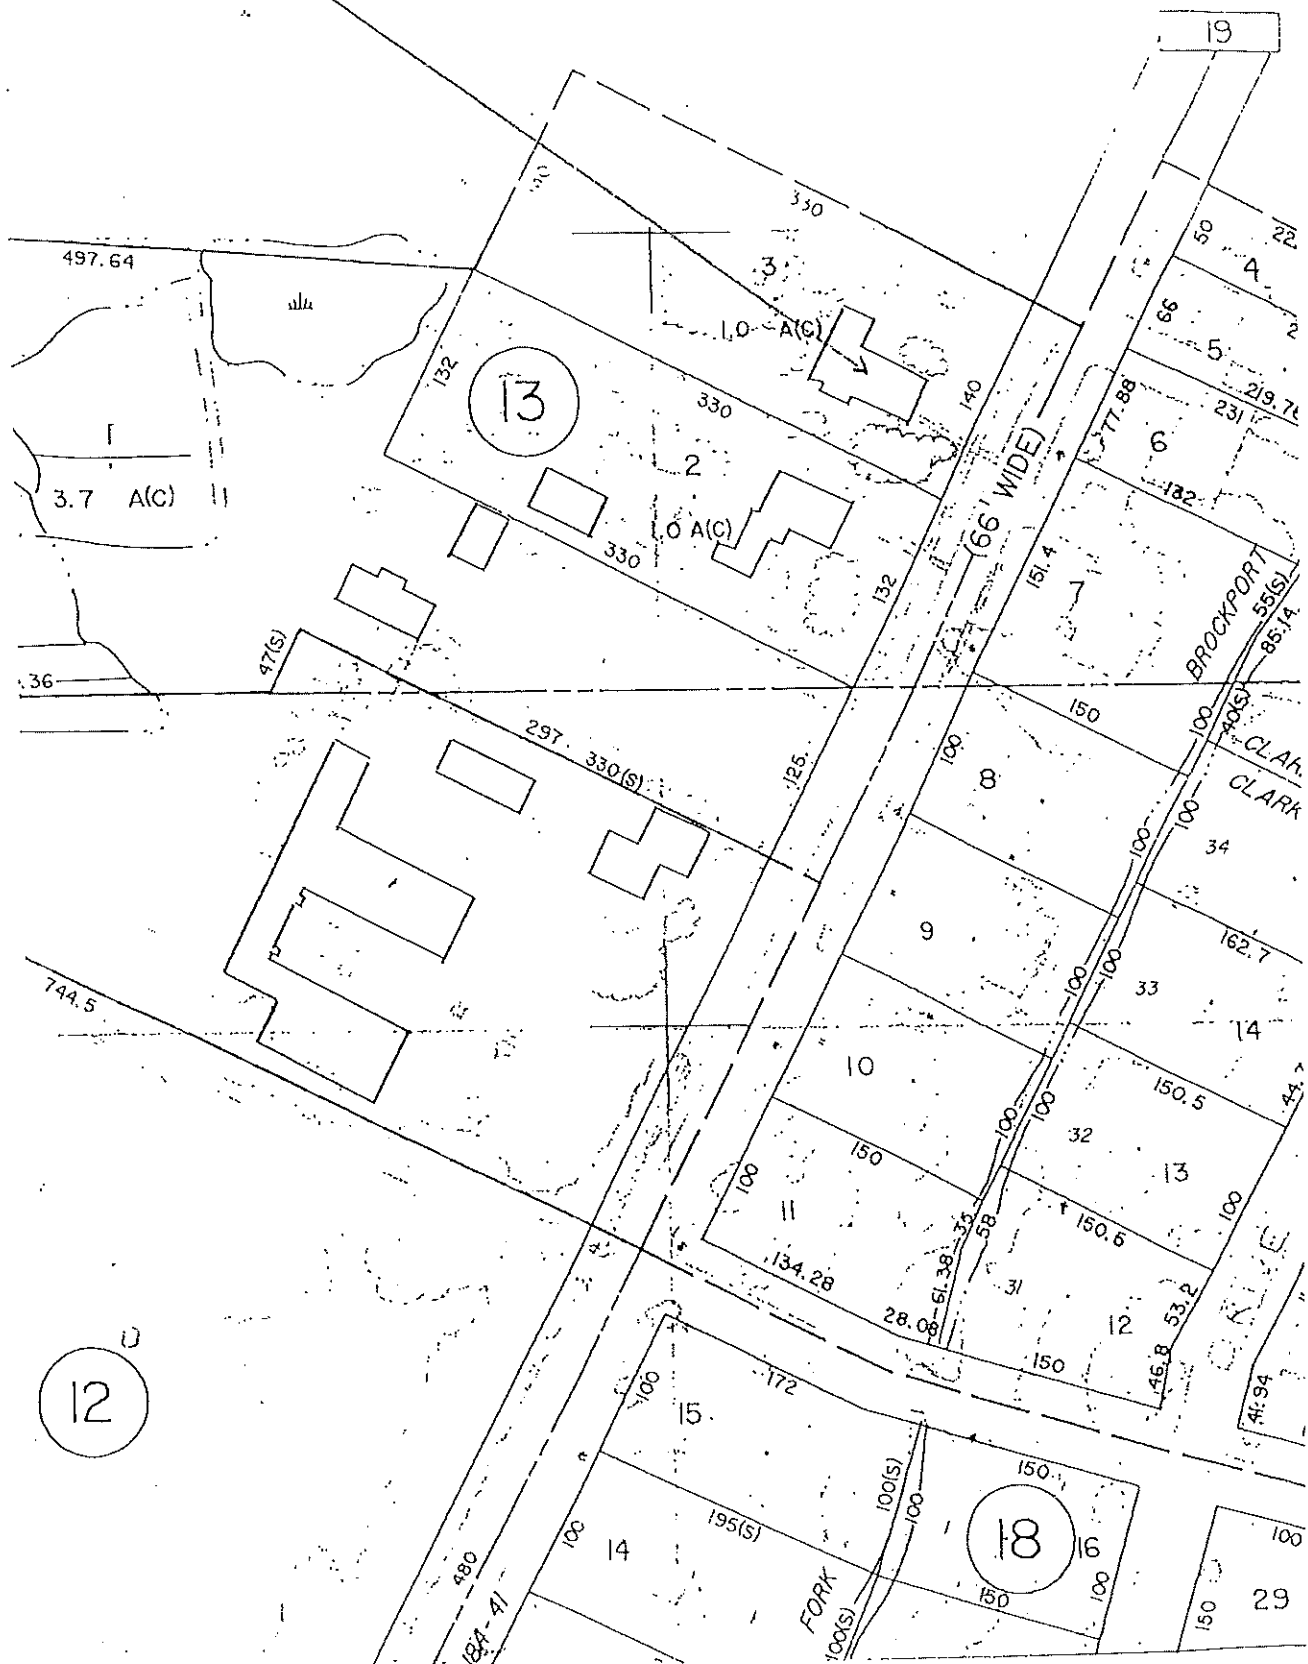
The Fowler House
3773 Lake Rd.

Also reflective of Greek Revival and Italianate influence, the house in scale and proportion remains decidedly Federal. The full length front porch and low rear additions contribute horizontal massing to the 2 1/2 story main block. Interior spaces appear intact with the exception of a modern bathroom installed off the main bedroom of the second floor. The staircase remains intact and interior trim is plain with much of it appearing original to the structure. The Fowler House is another important example of the Federal influence in Clarkson.

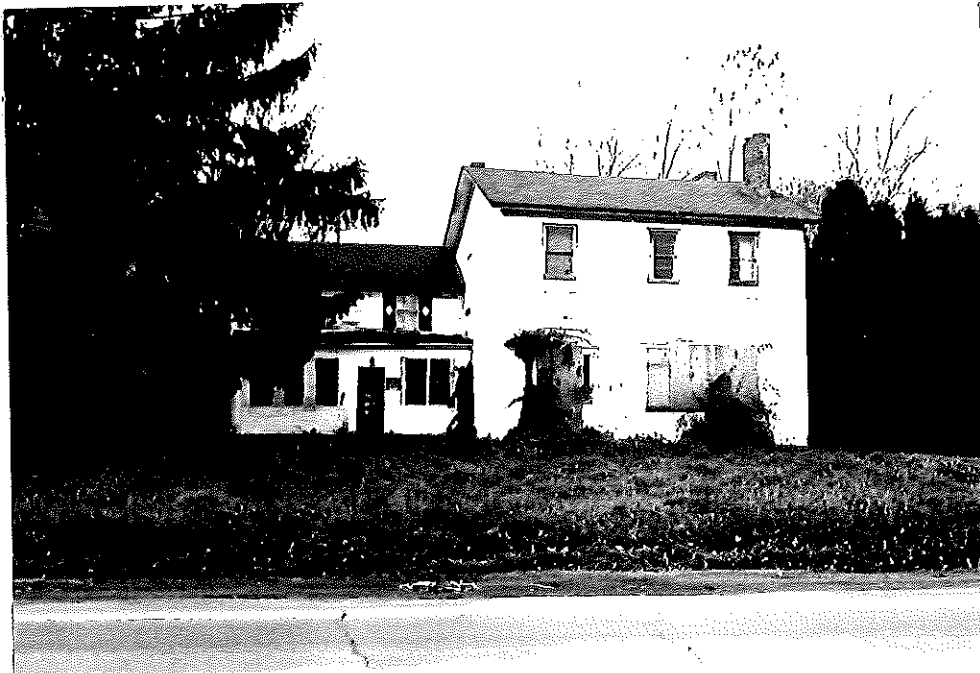
8. BUILDING MATERIAL: a. clapboard ☐ b. stone ☐ c. brick ☒ d. board and-batten ☐
e. cobblestone ☐ f. shingles ☐ g. stucco ☐ other: _____
9. STRUCTURAL SYSTEM: a. wood frame with interlocking joints ☐
(if known) b. wood frame with light members ☐
c. masonry load bearing walls ☒
d. metal (explain) _____
e. other rear additions: wood frame
10. CONDITION: a. excellent ☐ b. good ☐ c. fair ☐ d. deteriorated ☒
11. INTEGRITY: a. original site ☒ b. moved ☐ if so, when? _____
c. list major alterations and dates (if known):
wood frame south wing (date unknown)
picture window, front facade (date unknown)
front entrance fanlight transom covered (c. 1976-1987)

14. THREATS TO BUILDING: a. none known ☐ b. zoning ☐ c. roads ☐
 d. developers ☐ e. deterioration ☒
 f. other: _____
15. RELATED OUTBUILDINGS AND PROPERTY:
 a. barn ☒ b. carriage house ☐ c. garage ☐
 d. privy ☐ e. shed ☐ f. greenhouse ☐
 g. shop ☐ h. gardens ☐
 i. landscape features: _____
 j. other: _____
16. SURROUNDINGS OF THE BUILDING (check more than one if necessary):
 a. open land ☐ b. woodland ☐
 c. scattered buildings ☒
 d. densely built-up ☐ e. commercial ☐
 f. industrial ☐ g. residential ☒
 h. other: _____

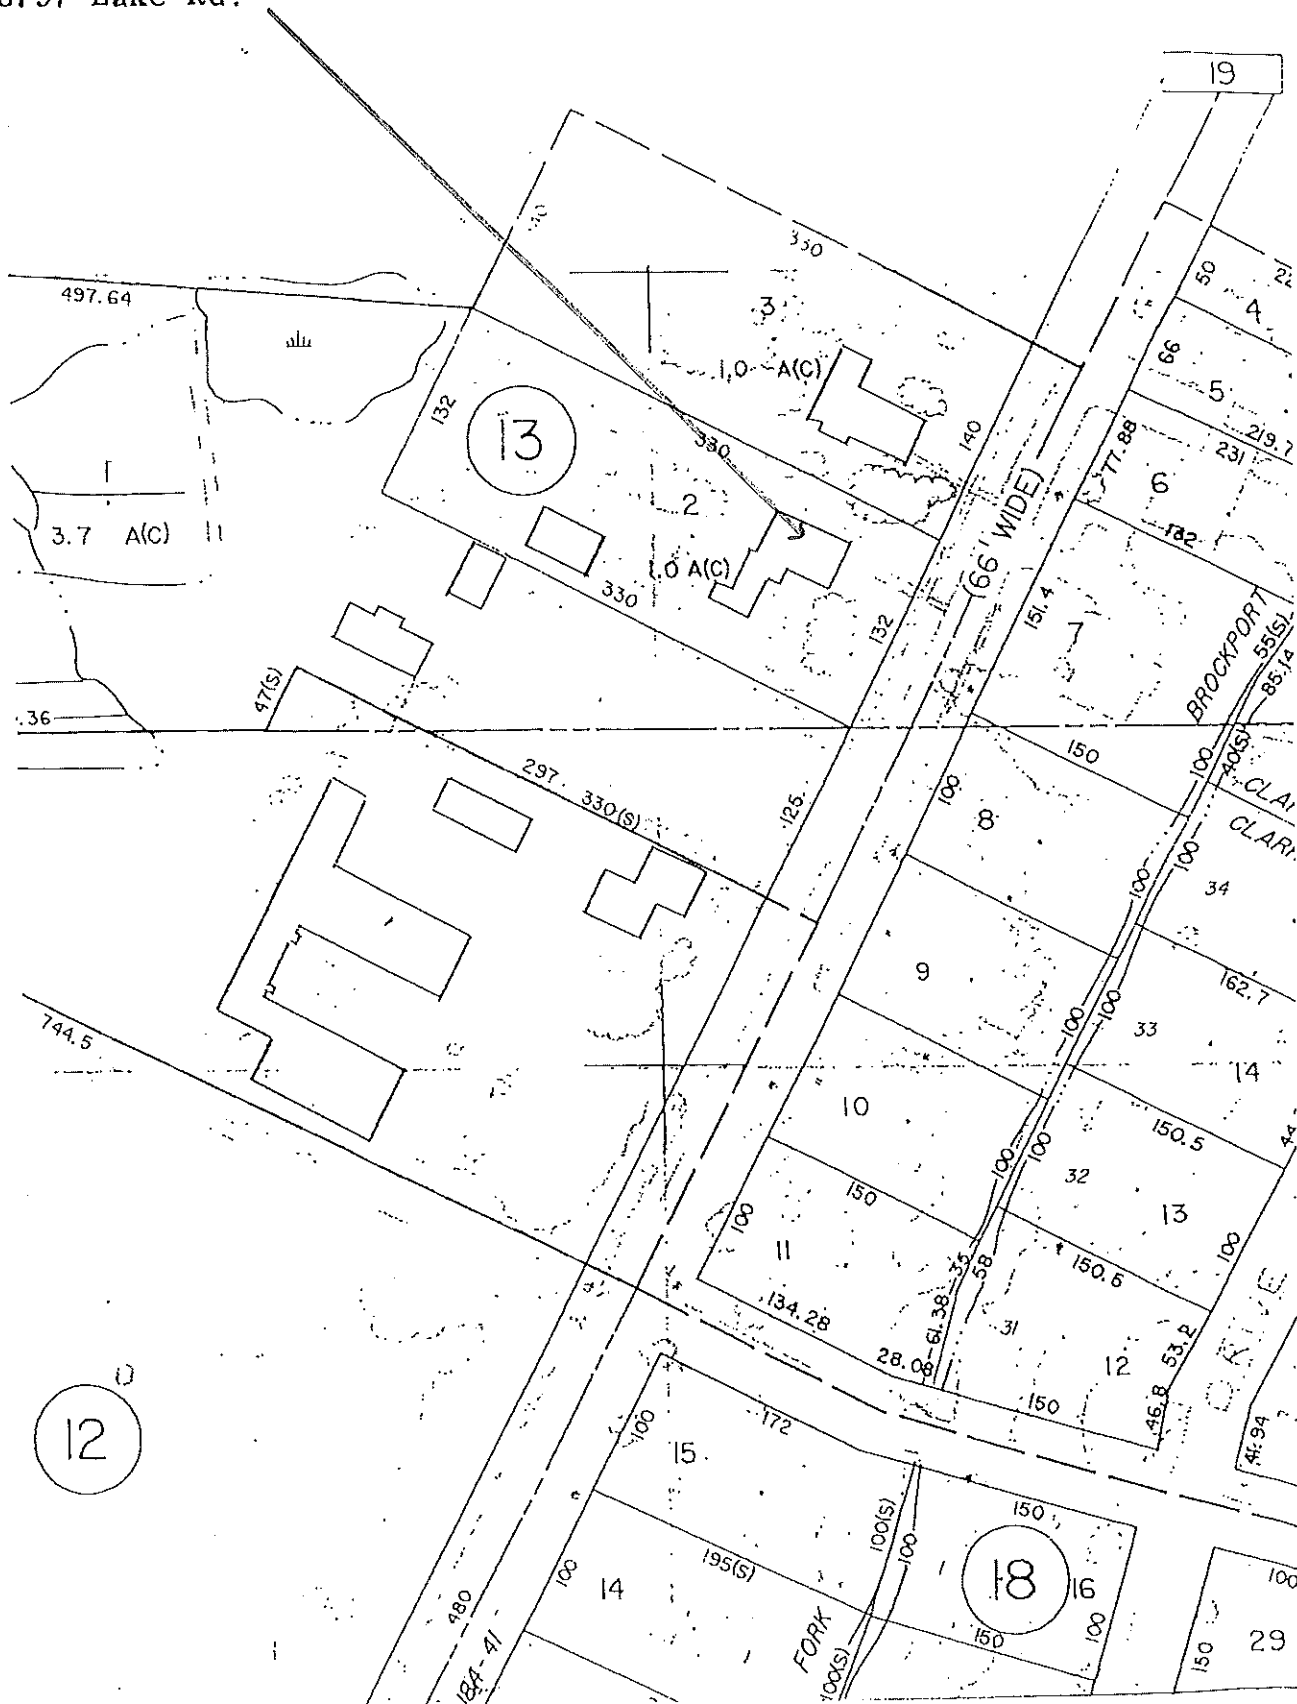
The Judge Bowman House
3797 Lake Rd.

18. The Judge Bowman House consists of a three-bay, side gable main block with an offset front entrance commonly found within the local historic overlay district. Unfortunately, this doorway is much deteriorated. An excellent photograph in Paul Malo's book, Landmarks of Rochester and Monroe County, confirms that the front entrance was of the type commonly installed in Clarkson's Federal homes. This photo, taken in 1973, shows lead tracery in the elliptical fanlight only and not in the vertical rectangular sidelights. Graceful Ionic colonnettes flank the sidelights while the elliptical lintel and sill are of cut stone. No other decorative features are evident on the facade and the south wing is non-contributing. Overall, the house is sadly deteriorated and neglected.

20. The Judge Bowman House is yet another example of the Federal influence in Clarkson. Although deteriorated, the house is an important visual element in the continuity of Clarkson's most significant historic row.

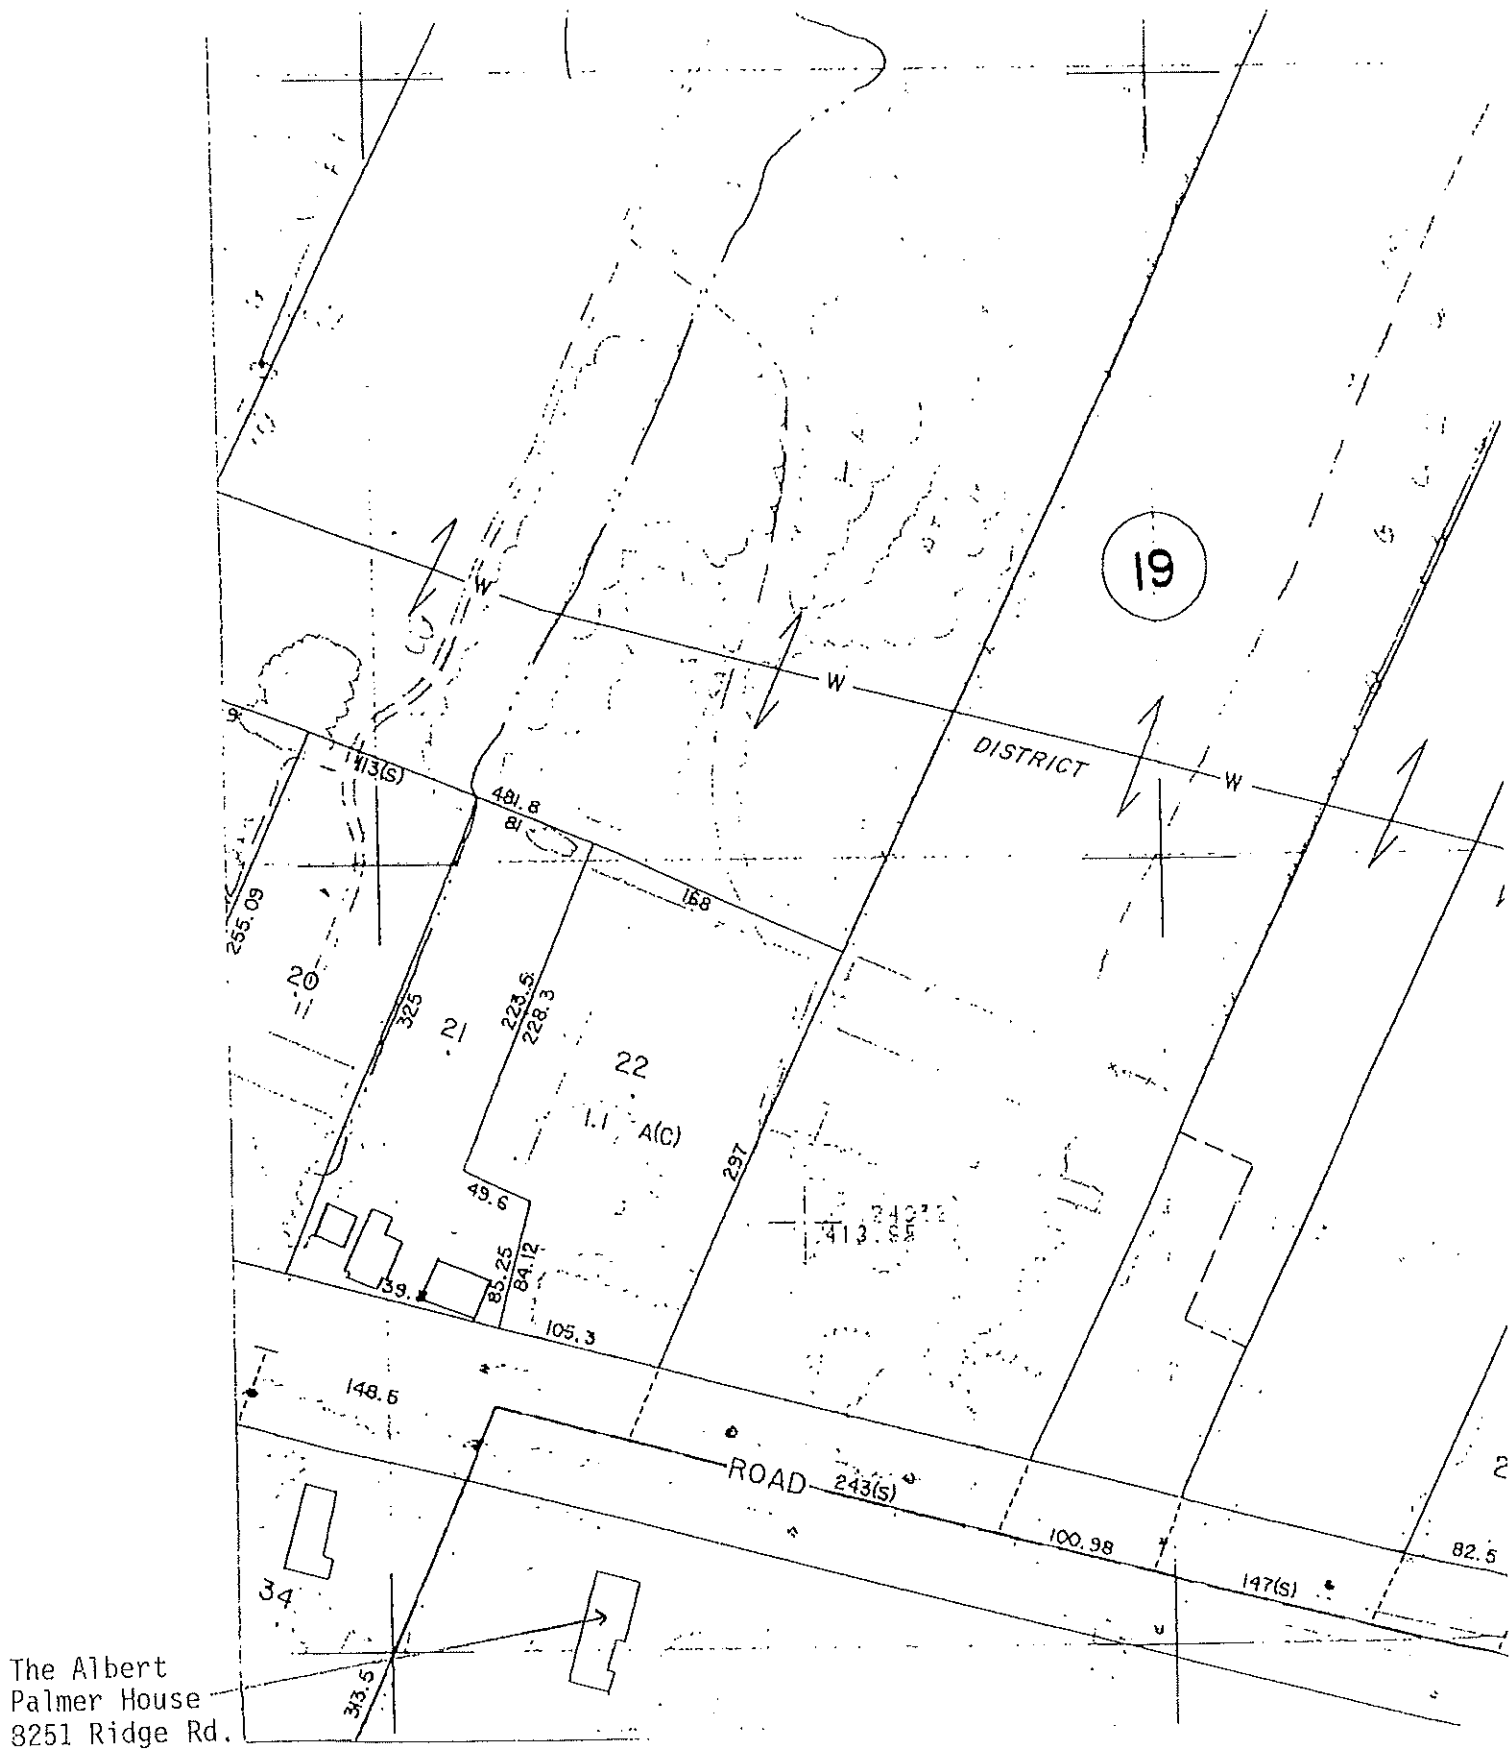
20. The Albert Palmer House is an outstanding example of the Federal style of architecture in Monroe County. Somewhat typical is the front gable, offset front entrance and unevenly spaced windows. The elaborate door surround crowned by a small bracketed cornice is unmatched within Clarkson. Other classical detailing is somewhat restrained and typifies the simple elegance of Federal craftsmanship. The vertical massing of the narrow facade creates an imposing symmetry perfectly accented by the corner pilasters. The Palmer House is the most perfectly balanced and defined example of the Federal style in Clarkson and ranks as an important Monroe County landmark.

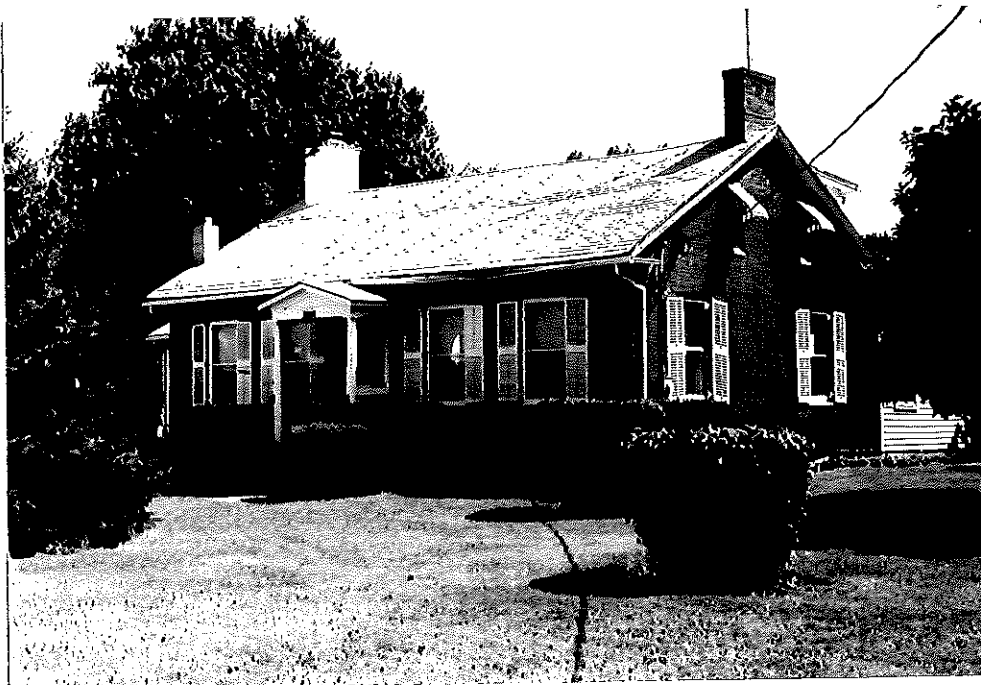
8319 Ridge Rd.
West

Although somewhat altered with its two additions and raised rear roof, the house expresses a rural rendition of a simple Federal influence without the elaborate entrance found on other Federal homes within the local historic district. The painted brick appears to have come from the local brickyard and suggests a construction date prior to 1850.

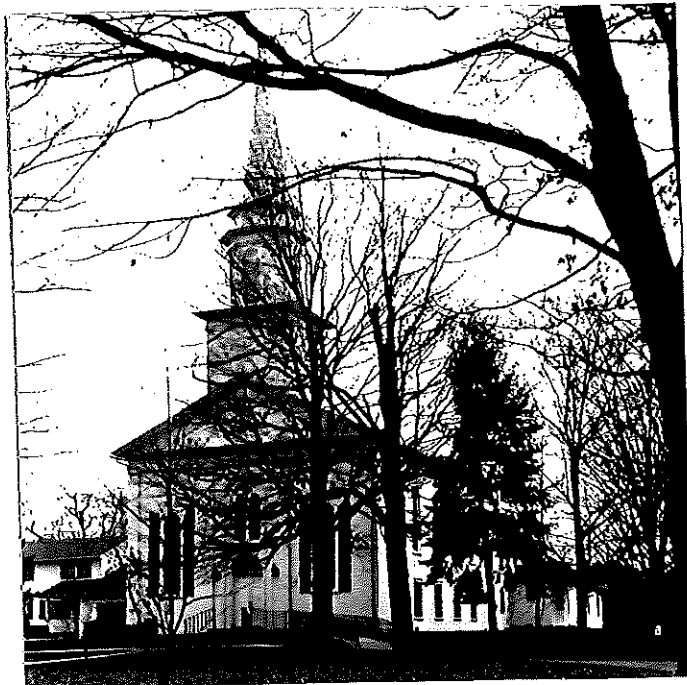
Congregational Church, 8339
Ridge Rd. West

18. The Congregational Church was patterned after traditional New England models and features a front gable center entrance facade with an unbroken modillioned pediment. The steeple tower may be original except for the spire which appears to have been replaced or added during the late nineteenth century. The three-bay facade is accented by monumental pilasters. Paired round-headed windows appear over the main entrance which features an unusual glass transom set in a round arch with archivolt trim. Single, narrow round-headed windows are set in the corresponding bays on either side of the entrance. These windows suggest an informal Italianate or Romanesque Revival influence.

20. Built in 1825, the Congregational Church has long been a significant visual landmark along Ridge Rd. The church reflects the New England architectural influence which touched western New York as a result of migrations from the eastern seaboard initiated by the abundance of land west of Massachusetts and Vermont. The church has been in continuous use as a place of worship since it was built and is one of the oldest surviving church buildings in Monroe County. Architecturally, the church illustrates the strong local influence of the Italianate style on a prevailing Federal form. The facade has remained virtually unchanged since the late nineteenth century. Along with the adjacent Clarkson Academy also owned by the Congregational Society, the Congregational Church is an important visual element of the village green east of the crossroads (Lake Rd.-Ridge Rd. intersection).

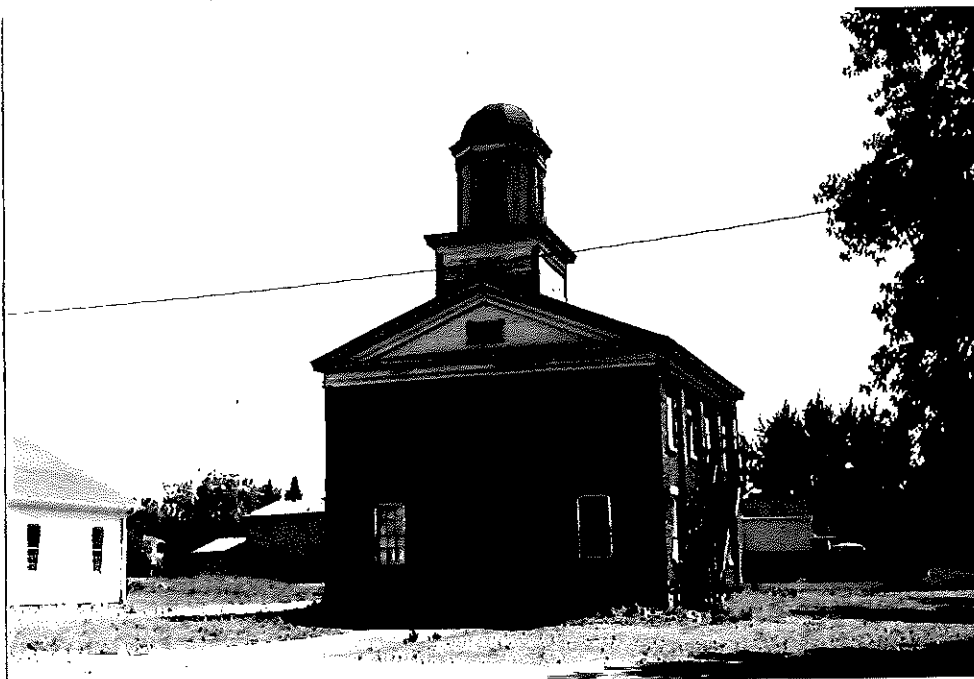
Clarkson
Academy
8343 Ridge
Rd.

18. The Clarkson Academy is a late Greek Revival building exuding a classical simplicity of detailing which adds an appealing integrity to institutional structures. Massive in scale and proportion, the pedimented three-bay facade is ornamented with wide vertical brick piers, flat stone lintels & sills and the whole is capped by a wooden bell tower which still houses the original bell. A small dentil band enhances the cornice. A rear wooden frame addition and detached shed are non-contributing.

20. Built in 1853, the present school stands on the site of the earlier Clarkson Academy, constructed c. 1825. The Academy was touted as the educational center of western New York which trained young persons as lawyers, ministers and teachers. In 1852, this building burned and was replaced by the Brockport Normal School which operated within the present schoolhouse into the 1940's. Built with local brick, the Clarkson Academy is a vital visual component on the eastern axis of the Clarkson Historic Overlay District which terminates with the Albert Palmer House. The massive classical simplicity of the Academy offers a sharp contrast to the adjacent Federal style Congregational Church with its distinct vertical massing. The Clarkson Academy offers a welcome diversion from the predominantly residential theme of the local historic district.

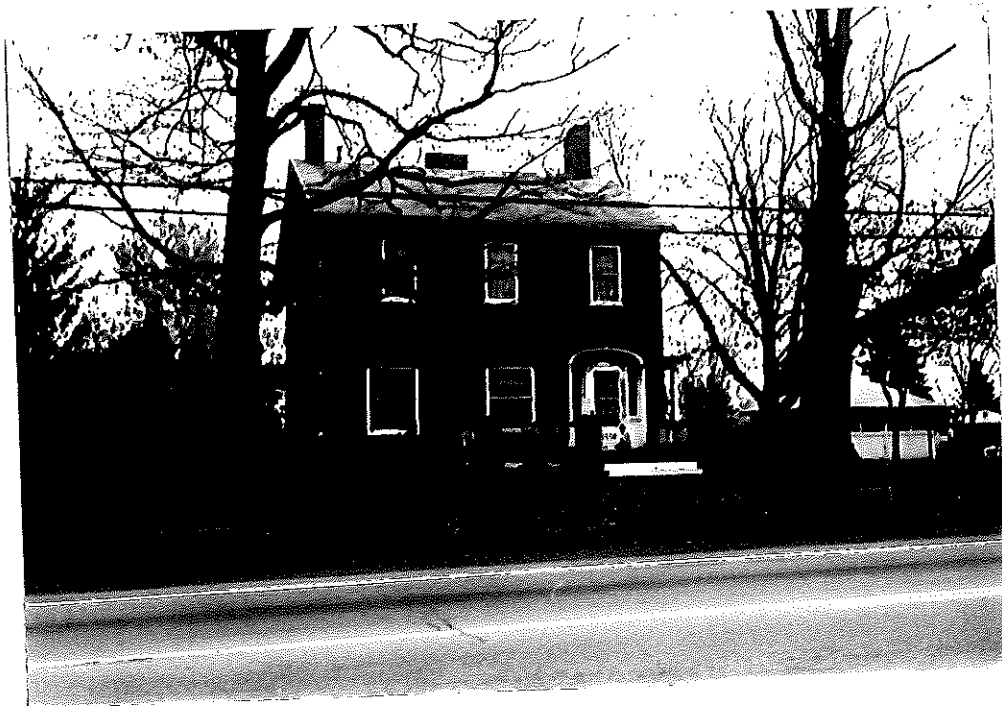
18. This imposing brick residence is another of Clarkson's Federal style houses. Featuring a three-bay façade with offset entrance and side gable roof, this structure also exhibits the familiar Federal doorway found in Clarkson. The entrance surround consists of recessed sidelights and an elliptical fanlight transom. The sidelights are flanked by square engaged colonnettes. Above the entrance an outline of a prior porch roof exists. The current cobblestone porch piers are non-contributing. The cornice is shallow-molded, and two small windows pierce the side gable peak.

The house also served as a convalescent home with the addition of the rear wing. This is certainly a divergence from traditional cottage industry associations and is a unique endeavor within local business tradition. Although moderately altered, this structure remains an important example of the Federal influence within the Clarkson area.

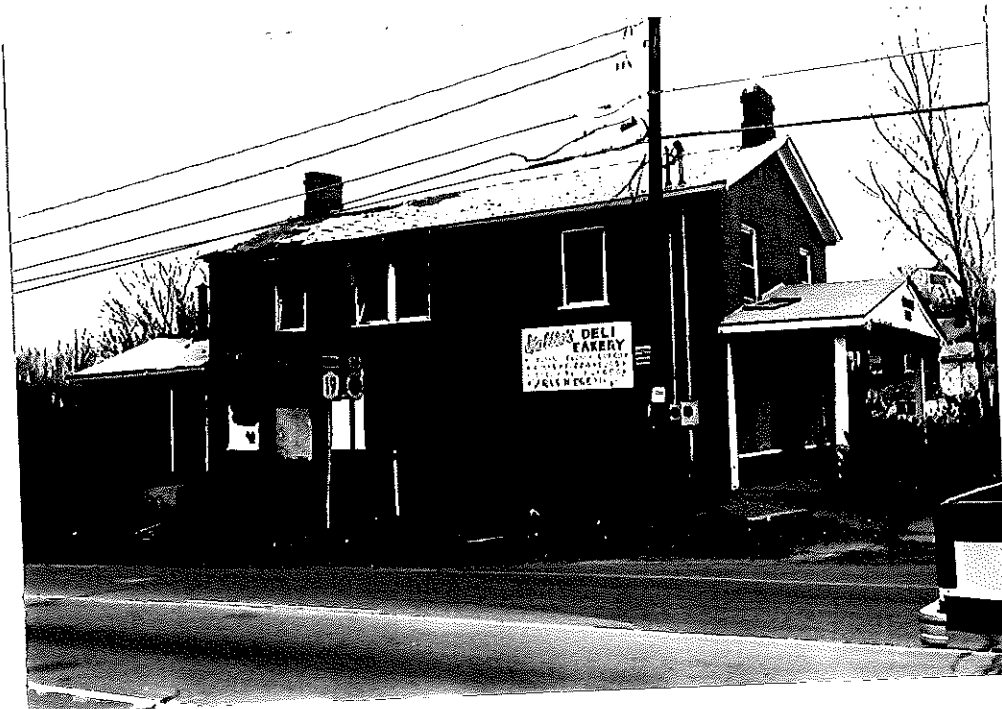
Galtro's
8376 Ridge Rd. West

This building is a plain vernacular store with a shallow molded cornice reflective of an early Federal influence. A small rear wing extends north and a plain pedimented porch is featured on the front (south) facade. Galtro's has been extensively damaged by a 1985 fire.

Galtro's is the oldest surviving commercial structure on any Ridge Rd. intersection within Monroe County. The store was in continuous use as a grocery for almost 160 years. Although fire damage and subsequent deterioration have ravaged the structure, Galtro's has been a significant commercial landmark along the Ridge for many years and deserves sensitive restoration.

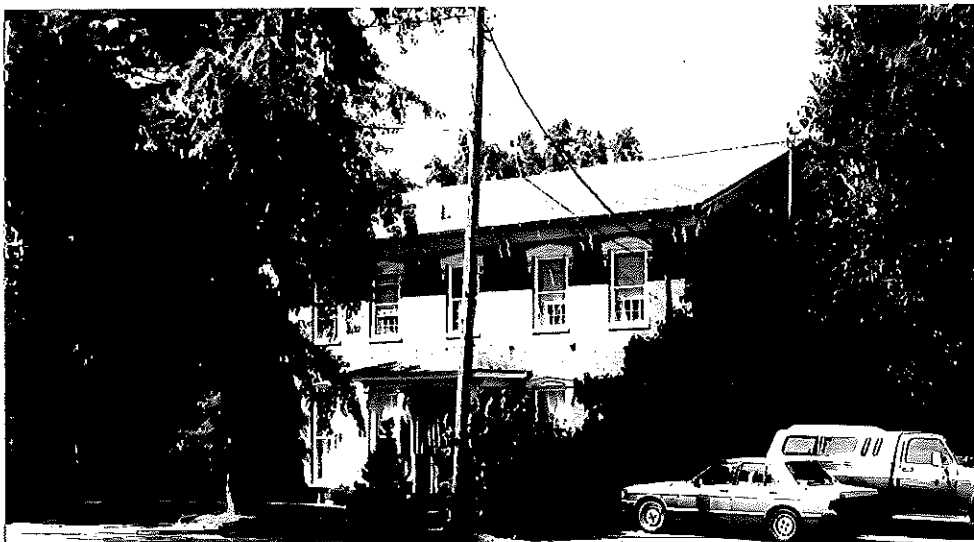
17. INTERRELATIONSHIP OF BUILDING AND SURROUNDINGS:
 (Indicate if building or structure is in an historic district)
 The Henry R. Selden House is located on a .5 acre site just west of the Lake Rd.-Ridge Rd. intersection and on the north side of Ridge Rd. No related outbuildings are on the site. The Selden House is within the local Clarkson Historic Overlay District.
18. OTHER NOTABLE FEATURES OF BUILDING AND SITE (including interior features if known):

In 1983, the Selden House was meticulously restored both inside and out. Painted woodwork was carefully removed, stripped and replaced. As a result of paint analysis, the trim was repainted using original colors. Wide board chestnut floors in the dining room and central hallway as well as the poplar floor in the parlor were cleaned and refinished. Original doors and hardware were retained where possible.

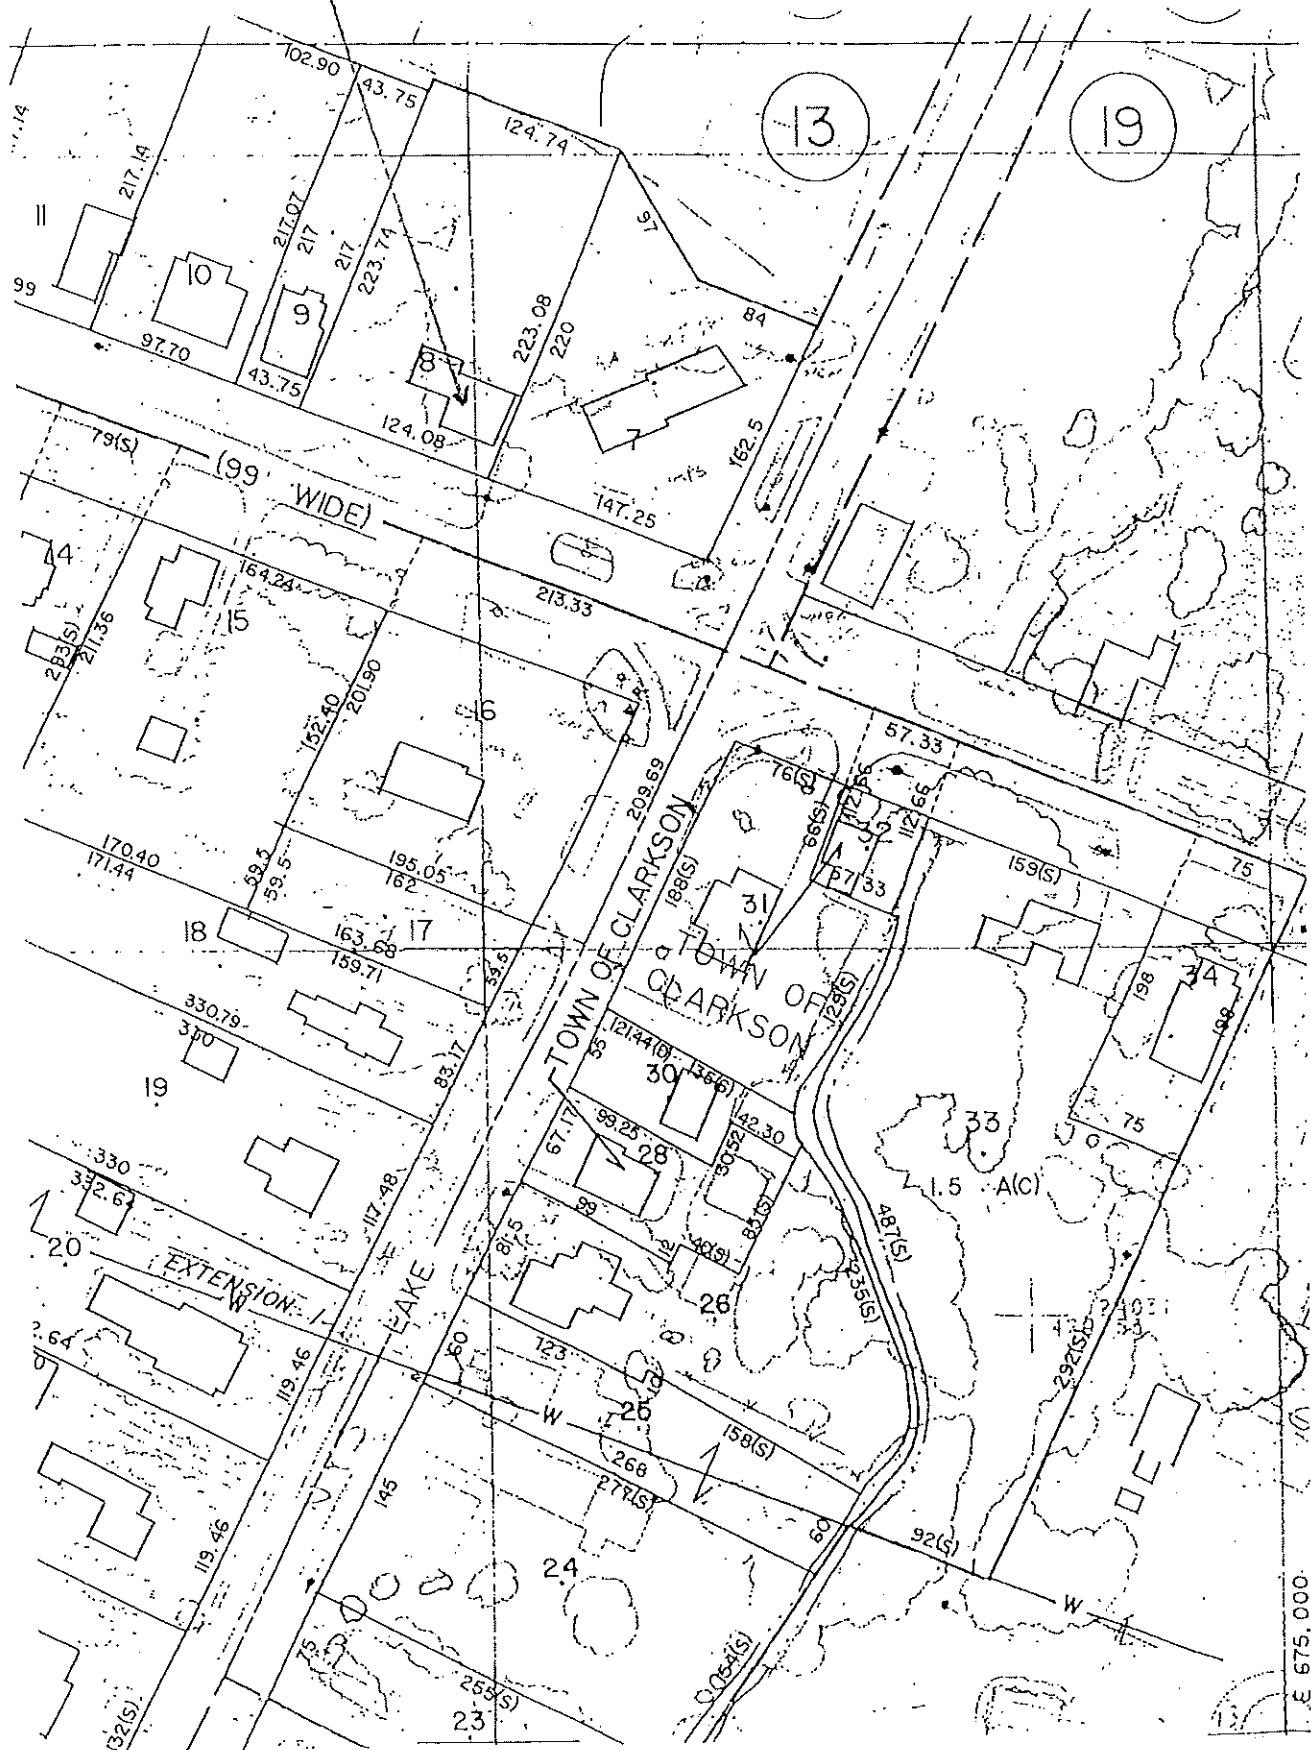
The Henry R. Selden House
8396 Ridge Rd. West

The Selden House underwent an extensive and successful restoration in 1983. Much painstaking effort went into a laudatory attempt to rehabilitate the house to reflect an earlier grandeur. As a result of this careful work, the Selden House remains an outstanding example of changing rural tastes and a testament to the ability of these rural residents to experiment with contemporary architectural styles.

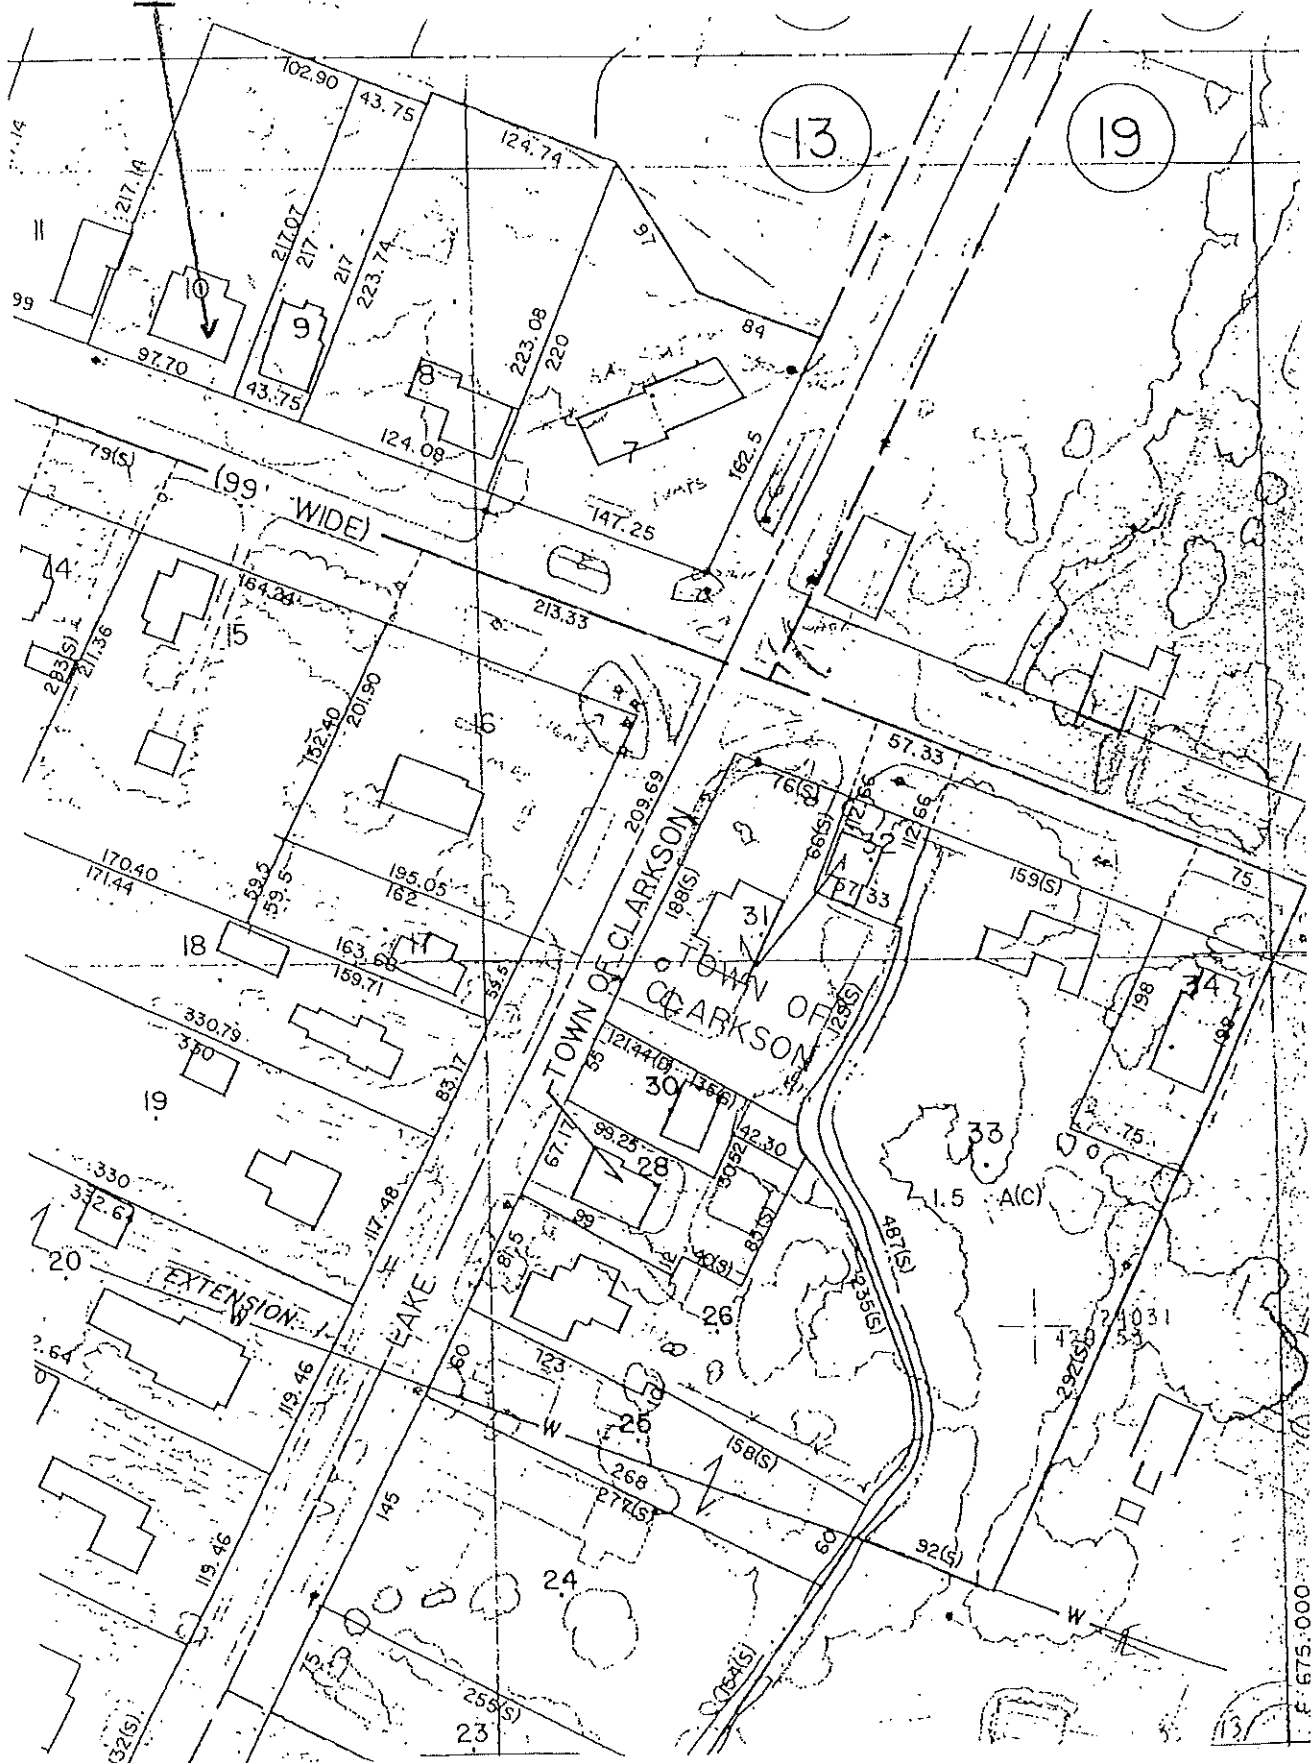
The Philip Boss House
8412 Ridge Rd. West

18. The Philip Boss House is yet another variation of the Federal style in Clarkson. The side gable, three-bay facade features an elegant door surround with rectangular sidelights and transom adorned with geometric lead tracery patterns. The sidelights are flanked by paired colonnettes. Unevenly spaced from its counterparts, a window is centered above the main entrance. The two ground floor windows have been substantially enlarged. Inverted elliptical windows are found in each side gable elevation. A dentil band enhances the roofline cornice and a wooden stoop with balustrade does not visually impede the distinctive entrance. A white picket fence at the front edge of the property greatly enhances site integrity. The brick walls are over 1 1/2 feet thick. A frame addition was added to the west elevation in 1856.

The original kitchen has been retained with fireplace & dutch oven intact along with hand-hewn ceiling beams. Original wide-board floors are found in upstairs rooms. A total of four original fireplaces and two original mantels remain within the house.

Although not as distinctive an example of the Federal style as the Albert Palmer House, the Philip Boss House retains much original design integrity. The doorway is particularly distinctive and offers another version of the popular Federal doorways in Clarkson. The Boss House has ineluctable links to the cottage industries which flourished along Ridge Rd. and remains an integral component of the local historic district.

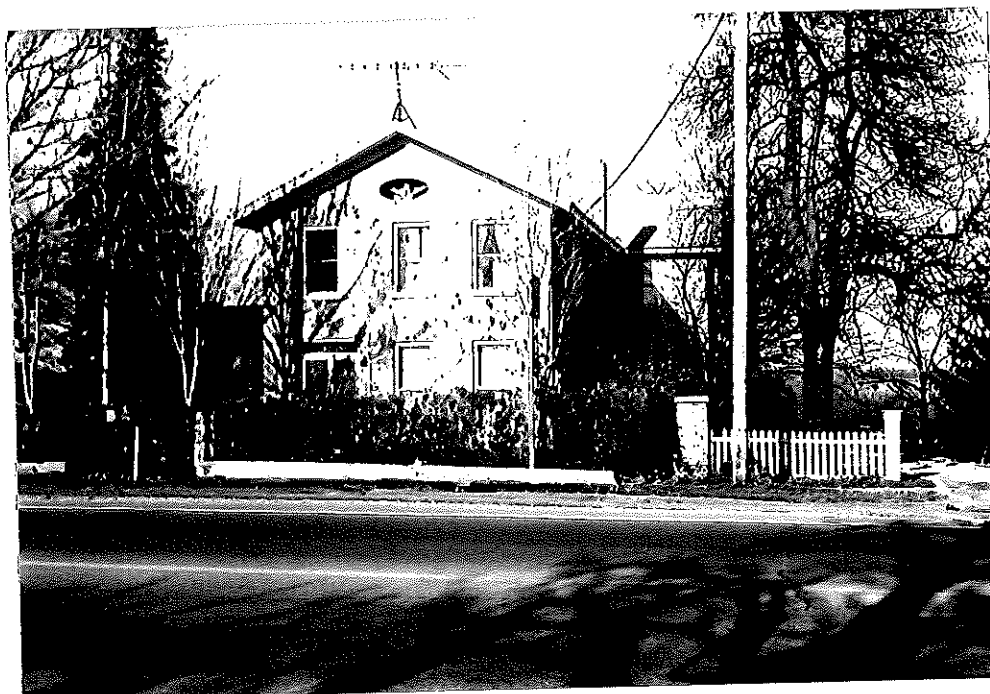
12. PHOTO:

The Cotter House features a three-bay facade with offset front entrance. An elliptical window is found within the pediment and other windows are capped with brick flat arch lintels. The entrance has been altered with only a rectangular glass transom remaining. No fireplaces remain.
