Clarkson Township, Monroe
County, New York

Historic Site Survey

Prepared for the
Monroe County Community
Development Administration

July, 1987

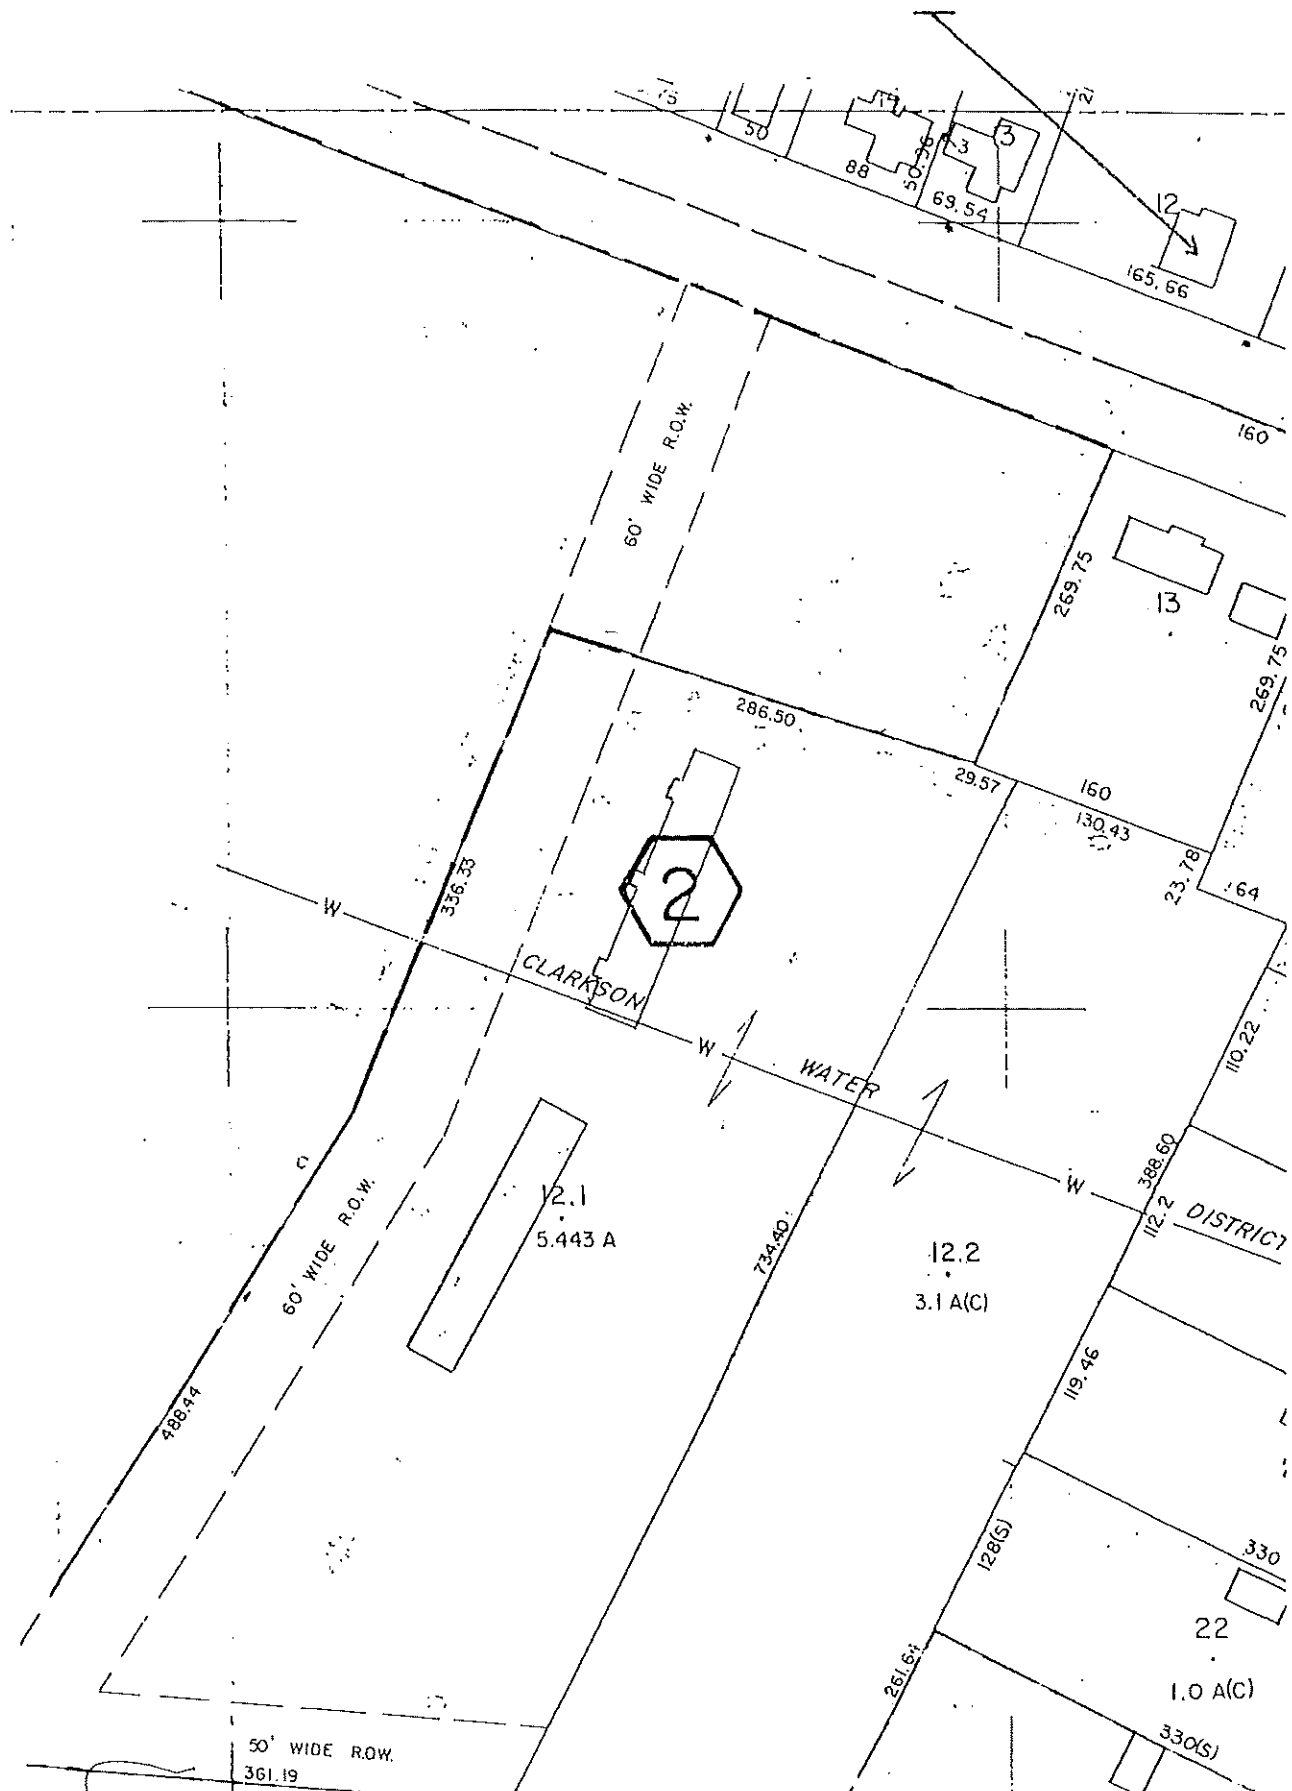
8428 Ridge Rd. West

This house is a gable front and wing Folk Victorian design
 that is unadorned with elaborate detailing. Beveled shutters
 are found on the windows and simple spindle columns support
 the front porch.

This house is an expression of changing rural tastes following
 the stylistic expressions of the early and mid-nineteenth
 century. Around the turn of the century, rural architecture
 embraced a simpler Victorian form which may be a more authentic
 expression of rural character than more pretentious Greek
 Revival and Federal designs found elsewhere in Clarkson.
